Brookfield Town Hall Prioritized Recommendations Cost Estimate

**Prepared By
Austin Design, Inc.**

Town Hall - Phased access improvement and re-use study

6 Central Street - Brookfield, Massachusetts

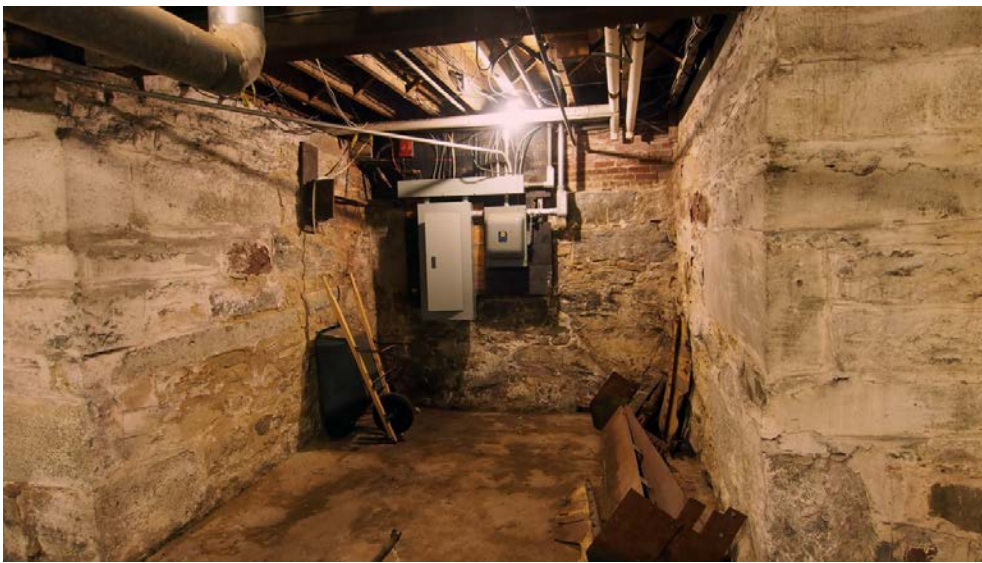
Stone foundation wall, brick knee wall above, 2x12 exposed floor joists

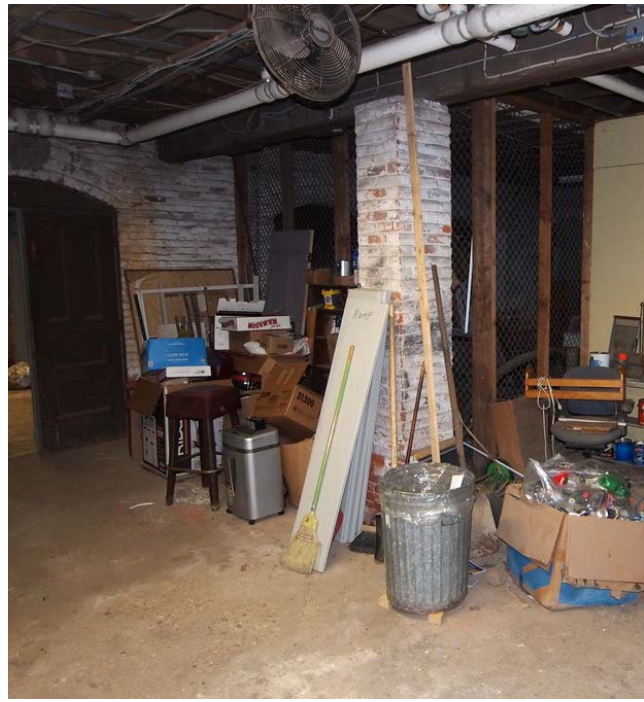
Arched opening, brick pier, wood beam and wood joists.

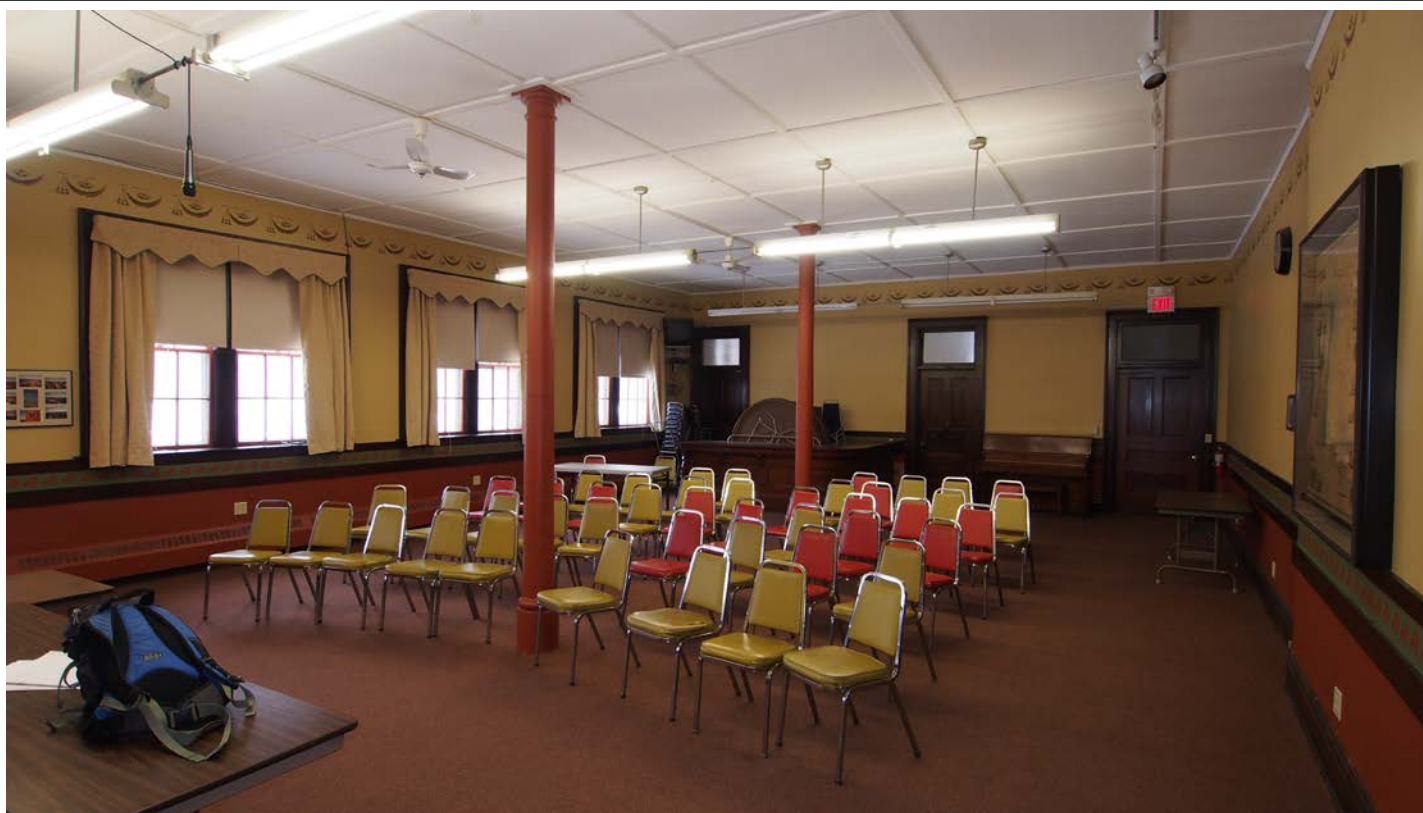
Central core – Banquet hall showing steel columns. Wood beam carrying second floor structure is above lowered ceiling.

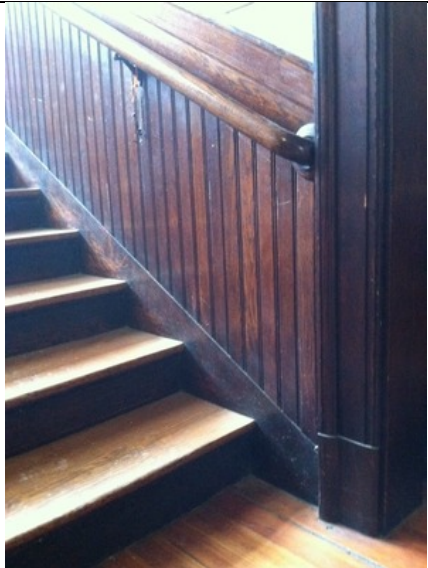
<p>3.1.a</p>	<p>Monumental stair is non-compliant due to:</p> <ul style="list-style-type: none"> • Non-compliant railings, size of handrail • Handrails lack extensions at top and bottom of run. • Gripping surface is interrupted and not continuous. • No rail on guard <ul style="list-style-type: none"> • <i>Request variance from MAAB to maintain existing handrails.</i> • <i>Install an additional compliant handrail on outside wall of the stairs if feasible and approved by MHC.</i> 	<ul style="list-style-type: none"> • 521CMR 27.4 Stair Handrails: Handrails shall comply with 27.4.1 Location, 27.4.2 Height, 27.4.3 Extensions, 27.4.4 Size, 27.4.5 Shape, 27.4.6 Surface, 27.4.7 Clearance, 27.4.8 End Condition, 27.4.9.

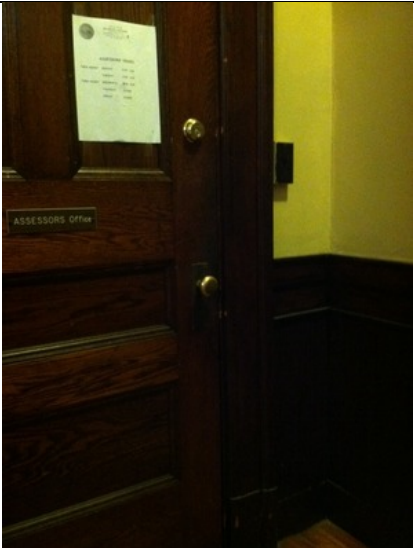
<p>5.2.a</p>	<p>Most doors are non-compliant:</p> <ul style="list-style-type: none"> • As a general condition, door hardware are non-compliant knobs • <i>Replace knobs with lever handles consistent with historic character of the building.</i> 	<ul style="list-style-type: none"> • <u>521CMR 26.11 Door Hardware: Type:</u> Handles, pulls, latches, locks, and other operating devices on accessible doors shall have a shape that is easy to operate with one hand and that does not require tight grasping, tight pinching, or twisting of the wrist to operate. Lever-operated mechanisms, push-type mechanisms, and U-shaped handles are acceptable designs. When sliding doors are fully open, operating hardware shall be exposed and usable from both sides

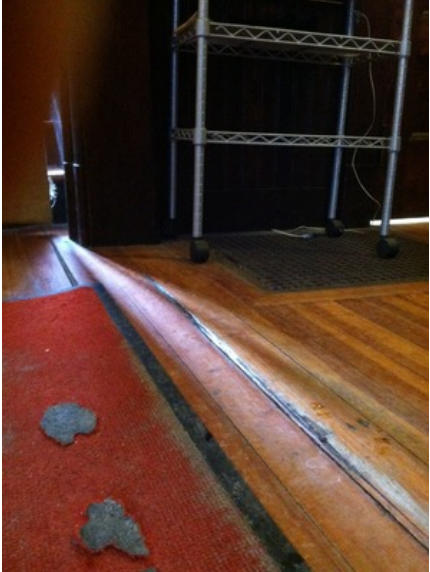
<p>Main entry hall is non-compliant due to:</p> <ul style="list-style-type: none"> • Buckled wood flooring at threshold <p>• <i>Repair wood flooring</i></p> <ul style="list-style-type: none"> • 521CMR 26.10.2 Thresholds: Changes in floor finish materials shall have an edge strip or threshold that is beveled at a ratio of one-in-two (1:2) (50%). • 521CMR 29.2.2 Changes in Level: Changes in level greater than ¼ inch and less than ½ inch shall be beveled with a slope no greater than one-in-two (1:2) (50%). See Fig. 29a.
<p>5.4 Building Interior: First Floor: <i>Most Doors on First Floor:</i></p>		
<p>5.4.a</p>

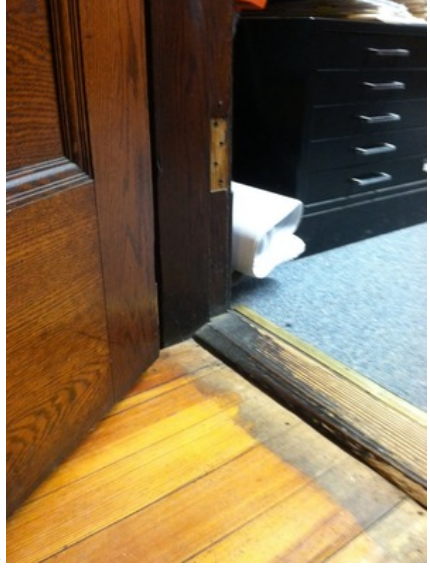
<p>First floor thresholds are non-compliant due to:</p> <ul style="list-style-type: none"> • As a general condition at all office partitions, the transition plate at partition doorways is too steep for the height of the threshold plate <p>• <i>Add transition plates to existing thresholds..</i></p> <ul style="list-style-type: none"> • 521CMR 26.10.2 Thresholds: Changes in floor finish materials shall have an edge strip or threshold that is beveled at a ratio of one-in-two (1:2) (50%). • 521CMR 29.2.2 Changes in Level: Changes in level greater than ¼ inch and less than ½ inch shall be beveled with a slope no greater than one-in-two (1:2) (50%). See Fig. 29a

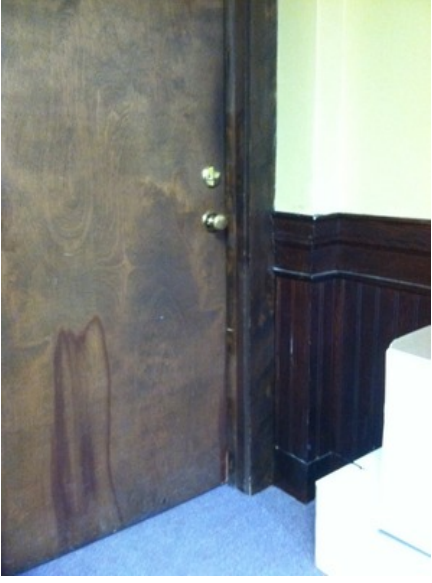
<p>First floor Building Inspector's office is non-compliant due to:</p> <ul style="list-style-type: none"> • Door width does not meet minimum 32" clear opening requirement • Insufficient push side clearance on both doors • Door hardware are non-compliant knobs <p>• <i>Install new power door opener</i></p> <p>• <i>Or request variance from MAAB.</i></p>
<p>5.5.b</p>

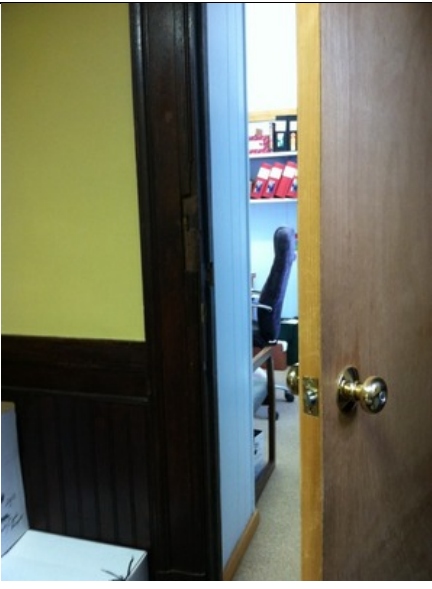
<p>• 521CMR 26.11 Door Hardware: Type: Handles, pulls, latches, locks, and other operating devices on accessible doors shall have a shape that is easy to operate with one hand and that does not require tight grasping, tight pinching, or twisting of the wrist to operate. Lever-operated mechanisms, push-type mechanisms, and U-shaped handles are acceptable designs. When sliding doors are fully open, operating hardware shall be exposed and usable from both sides.</p> <p>• <i>Replace knobs with lever handles consistent with historic character of the building.</i></p>

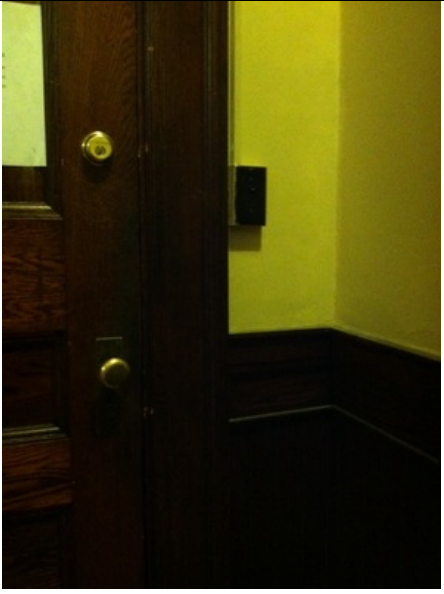
<p>First floor Assessor's office is non-compliant due to:</p> <ul style="list-style-type: none"> • Insufficient pull side clearance of 17" • Door hardware are non-compliant knobs. <p>• <i>Install new power door opener</i> • <i>Or request variance from MAAB.</i></p> <ul style="list-style-type: none"> • 521CMR 26.6.3 Door Pull Side Clearance: A minimum of 18 inches of clear floor space shall be provided on the latch pull side of the door when the clear floor space in front of the door is a minimum of 60 inches. See Fig. 26.d. • 521CMR 26.11 Door Hardware: Type: Handles, pulls, latches, locks, and other operating devices on accessible doors shall have a shape that is easy to operate with one hand.
<p>5.7 Building Interior: First Floor: <u>First Floor Selectman's Office:</u></p>		
<p>5.7.a</p>

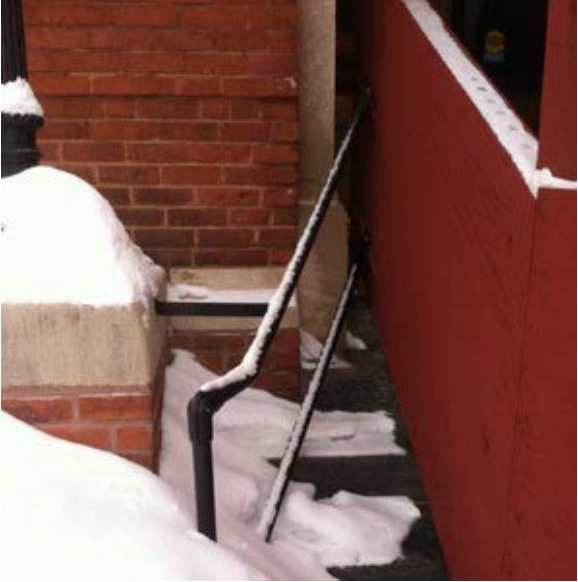
<p>X.1.a</p>	<p>Main Entrance is non-compliant:</p> <ul style="list-style-type: none"> • Gripping surface is interrupted and not continuous. • Hand rails lack required extension • Access to handrails is blocked by awning <p>• <i>Remove constructed awning and install compliant handrails on both sides of stair.</i></p>	<ul style="list-style-type: none"> • IBC 1012.4 Handrail Continuity: Handrail gripping surfaces shall be continuous, without interruption by newel posts and other obstructions. • IBC 1012.6 Handrail Extensions: Handrails shall return to a wall, guard or the walking surface or shall be continuous to the handrail of an adjacent stair flight or ramp run. Where handrails are not continuous between flights, the handrails shall extend horizontally at least 12 inches beyond the top riser and continue to slope for the depth of one tread beyond the bottom riser.

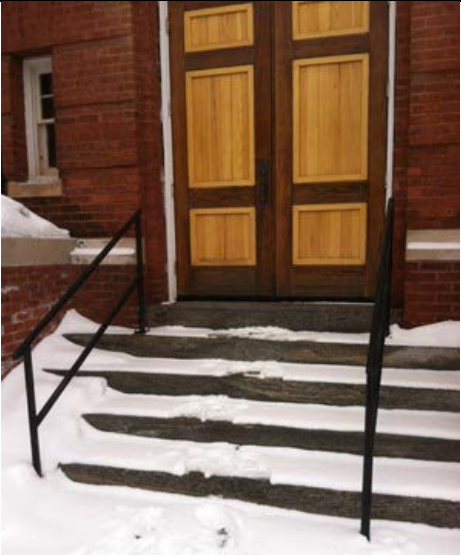
<p data-bbox="291 878 359 906">X.2.a</p>	<p data-bbox="968 355 1272 383">Entrance is non-compliant:</p> <ul data-bbox="968 423 1297 488" style="list-style-type: none"> • There is no exterior landing • Hand rails lack extensions <p data-bbox="968 883 1297 911">• <i>Install compliant handrails.</i></p>	<ul data-bbox="1551 358 2043 891" style="list-style-type: none"> • IBC 1009.5 Stairway Landings: There shall be floor or landing at the top and bottom of each stairway. The width of the landings shall not be less than the width of stairways they serve. • IBC 1012.6 Handrail Extensions: Handrails shall return to a wall, guard or the walking surface or shall be continuous to the handrail of an adjacent stair flight or ramp run. Where handrails are not continuous between flights, the handrails shall extend horizontally at least 12 inches beyond the top riser and continue to slope for the depth of one tread beyond the bottom riser.

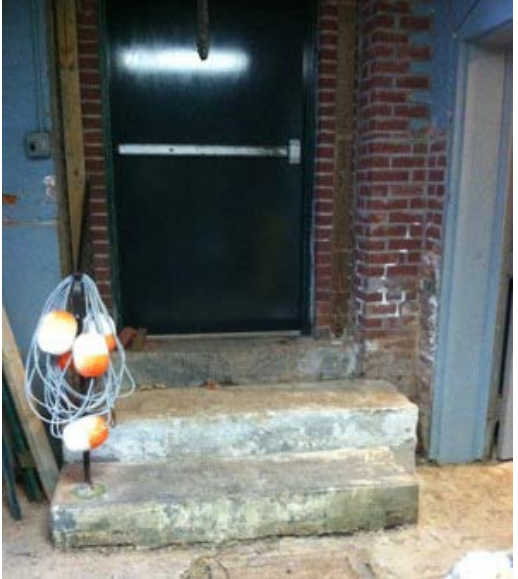
<p>X.3.a</p>	<p>East end entrance is non-compliant:</p> <ul style="list-style-type: none"> • Steps obstruct doorway to egress stair • Riser height too high at 8" • No interior landing • Non-compliant handrails <p>• <i>Renovate entrance as part of basement alterations.</i></p>	<ul style="list-style-type: none"> • IBC 1003.3.4 Clear Width: Protruding objects shall not reduce the minimum clear width of accessible routes. • IBC 1009.4.2 Riser Height and Tread Depth: Stair riser height shall be 7 inches maximum. Rectangular tread depths shall be 11 inches minimum. • IBC 1009.5 Stairway Landings: There shall be floor or landing at the top and bottom of each stairway. The width of the landings shall not be less than the width of stairways they serve. • IBC 1009.12 Handrails: Stairways shall have handrails on each side and shall comply with Section 1012.
--	---	---

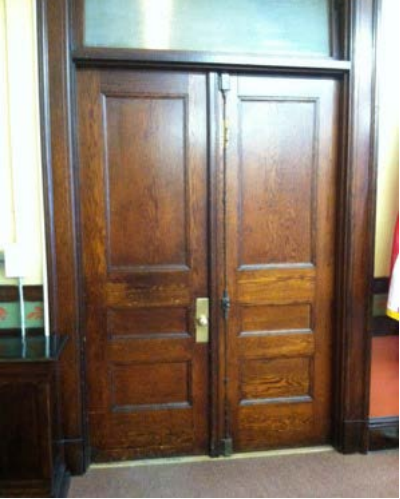
<p>Entrance to banquet hall is non-compliant:</p> <ul style="list-style-type: none"> • Entrance to the banquet hall has two independent door leaves, neither of which have a clear opening of the minimum 32 inches. • Closers are required on the doors <p>• <i>Add automatic door openers if required by building official..</i></p>	<ul style="list-style-type: none"> • <u>IBC 1008.1.1 Size of Doors:</u> The minimum width of each door opening shall be sufficient for the occupant load thereof and shall provide a clear width of 32 inches.

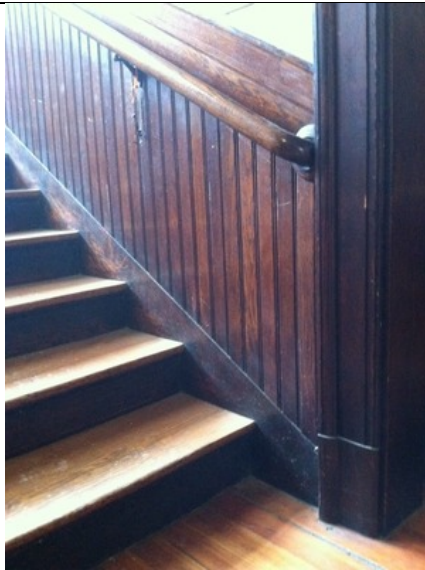
<p>1.2.a</p>	<p>Monumental stair is non-compliant due to guards and handrails:</p> <ul style="list-style-type: none"> • No rail on guard • Non-compliant railings, size of handrail • Gripping surface is interrupted and not continuous. • Handrails lack extensions at top and bottom of run. <p>• <i>Request variance from MAAB to maintain existing handrails</i></p> <p>• <i>Install an additional compliant handrail on outside wall of the stairs if feasible and approved by MHC.</i></p>	<ul style="list-style-type: none"> • IBC 1009.12 Handrails: Stairways shall have handrails on each side and shall comply with Section 1012. • IBC 1012.3.1 Handrail Type I: Handrails with a circular cross section shall have an outside diameter of at least 1 ¼ inches and not greater than 2 inches • IBC 1012.4 Handrail Continuity: Handrail gripping surfaces shall be continuous, without interruption by newel posts and other obstructions.

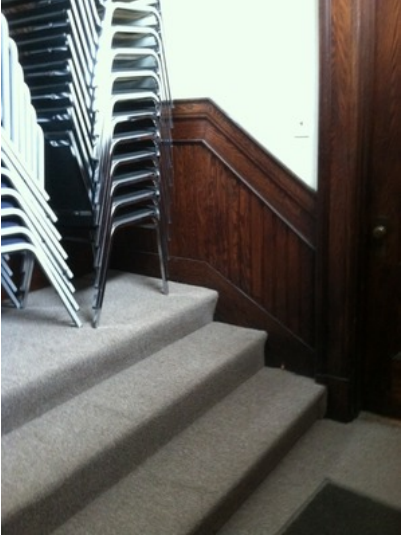
<p>1.3.a</p>	<p>Stairs to side exit are non-compliant:</p> <ul style="list-style-type: none"> • Handrail on one side only • Handrails lack extensions at top and bottom of run <ul style="list-style-type: none"> • <i>Request variance from MAAB to maintain existing handrails</i> • <i>Install an additional compliant handrail on outside wall of the stairs if feasible and approved by MHC.</i> 	<ul style="list-style-type: none"> • IBC 1009.12 Handrails: Stairways shall have handrails on each side and shall comply with Section 1012. • IBC 1012.6 Handrail Extensions: Handrails shall return to a wall, guard or the walking surface or shall be continuous to the handrail of an adjacent stair flight or ramp run. Where handrails are not continuous between flights, the handrails shall extend horizontally at least 12 inches beyond the top riser and continue to slope for the depth of one tread beyond the bottom riser.

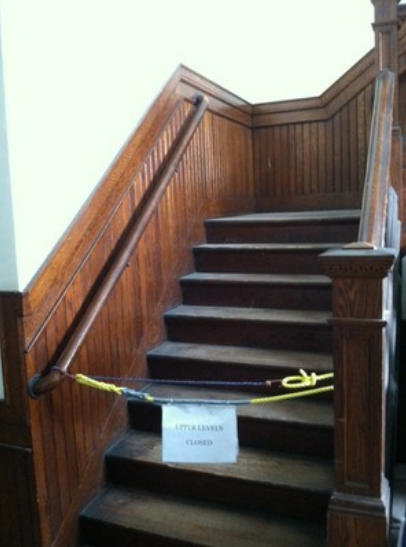
<p>1.4.a</p>	<p>Egress stair to second floor is non-compliant due to winders, tread depth and handrails:</p> <ul style="list-style-type: none"> • Non-compliant tread depth at 10" • Non-compliant winders down from third floor • Handrails lack extensions at top and bottom of run. <ul style="list-style-type: none"> • <i>Request variance from MAAB to maintain existing handrails</i> • <i>Install an additional compliant handrail on outside wall of the stairs if feasible and approved by MHC.</i> 	<ul style="list-style-type: none"> • IBC 1009.4.2 Riser Height and Tread Depth: Stair riser height shall be 7 inches maximum. Rectangular tread depths shall be 11 inches minimum. • IBC 1009.4.3 Winder Treads: Winder treads are not permitted in means of egress stairways except within a dwelling unit. • IBC 1012.6 Handrail Extensions: Handrails shall return to a wall, guard or the walking surface or shall be continuous to the handrail of an adjacent stair flight or ramp run.

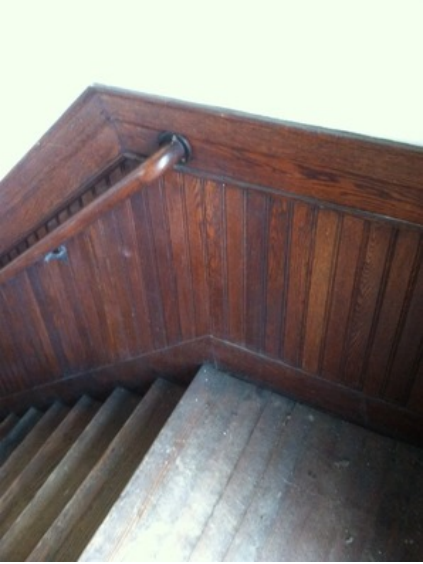
<p>2.1.a</p>	<p>Stair to mezzanine and third floor is non-compliant:</p> <ul style="list-style-type: none"> • Non-compliant tread depth at 10" and riser 7.5" • Non-compliant winders to mezzanine and third floor • Handrails are on one side only and are not continuous • Handrails are too large at 2 ¼" • Handrails lack extensions at top and bottom • Stairway is open to second floor landing and is not enclosed • <i>Request variance from MAAB to maintain existing handrails</i> • <i>Install an additional compliant handrail on outside wall of the stairs if feasible and approved by MHC</i> 	<ul style="list-style-type: none"> • IBC 1009.4.2 Riser Height and Tread Depth: Stair riser height shall be 7 inches maximum. Rectangular tread depths shall be 11 inches minimum. • IBC 1009.4.3 Winder Treads: Winder treads are not permitted in means of egress stairways except within a dwelling unit. • IBC 1009.12 Handrails: Stairways shall have handrails on each side and shall comply with Section 1012. • IBC 1012.3.1 Handrail Type I: Handrails with a circular cross section shall have an outside diameter of at least 1 ¼ inches and not greater than 2 inches

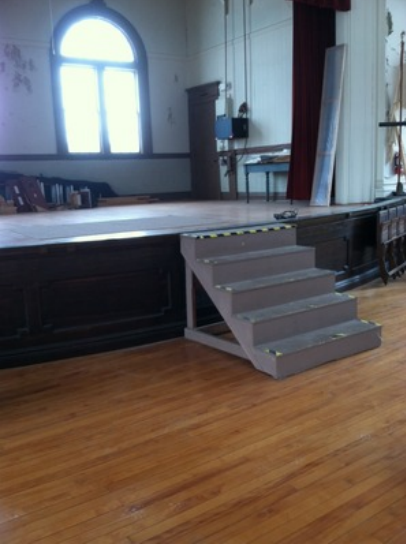
<p data-bbox="323 834 380 862">2.2.a</p>	<p data-bbox="968 319 1377 347">Auditorium is non-compliant due to:</p> <ul data-bbox="968 391 1528 591" style="list-style-type: none"> • Stairs to stage lack handrails. • Handrails lack extensions at top and bottom of run. • Doors lack panic hardware and closers. • Second egress is non-compliant in stair and door width <p data-bbox="968 802 1528 829">• <i>Install exit device and closer hardware on doors.</i></p>	<ul data-bbox="1554 326 2039 786" style="list-style-type: none"> • IBC 1009.12 Handrails: Stairways shall have handrails on each side and shall comply with Section 1012. • IBC 1012.6 Handrail Extensions: Handrails shall return to a wall, guard or the walking surface or shall be continuous to the handrail of an adjacent stair flight or ramp run. Where handrails are not continuous between flights, the handrails shall extend horizontally at least 12 inches beyond the top riser and continue to slope for the depth of one tread beyond the bottom riser.

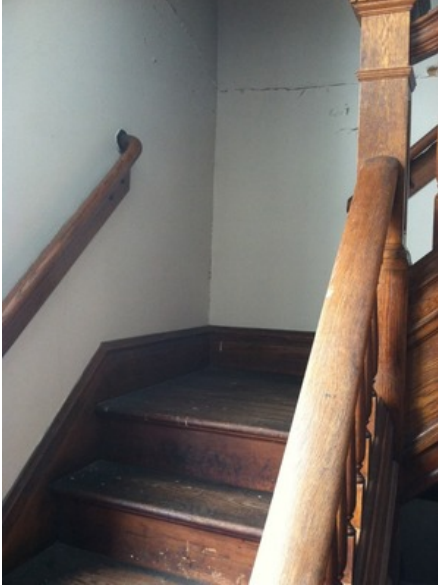
<p>2.3.a</p>	<p>Egress stair from balcony is non-compliant:</p> <ul style="list-style-type: none"> • Stair clear width reduced to 30" • Non-compliant tread depth at 10" and riser height at 7.5" • Handrails lack extensions at top and bottom of run. • Non-compliant window at stair <ul style="list-style-type: none"> • <i>Request variance from MAAB to maintain existing handrails</i> • <i>Install an additional compliant handrail on outside wall of the stairs if feasible and approved by MHC.</i> 	<ul style="list-style-type: none"> • IBC 1009.1 Stairway Width: The width of stairways shall be determined as specified in section 1005.1, but such width shall not be less than 44 inches. • IBC 1009.4.2 Riser Height and Tread Depth: Stair riser height shall be 7 inches maximum. Rectangular tread depths shall be 11 inches minimum. • IBC 1012.6 Handrail Extensions: Handrails shall return to a wall, guard or the walking surface or shall be continuous to the handrail of an adjacent stair flight or ramp run. Where handrails are not continuous between flights, the handrails shall extend horizontally at least 12 inches beyond the top riser and continue to slope for the depth of one tread beyond the bottom riser.

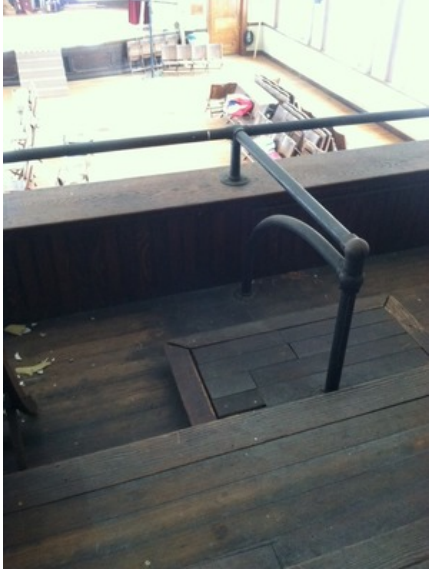
<p>2.4.a</p>	<p>Auditorium balcony is non-compliant due to:</p> <ul style="list-style-type: none"> • Continuous railings are not provided at stairs • Guards are non-compliant at 27" <ul style="list-style-type: none"> • <i>Eliminate access to balcony</i> 	<ul style="list-style-type: none"> • IBC 1009.12 Handrails: Stairways shall have handrails on each side and shall comply with Section 1012. • IBC 1013.1 Guards: Guards shall be located along open-sided waling surfaces, including mezzanines, equipment platforms, stairs, ramps and landings that are located more than 30 inches measured vertically to the floor or grade below at any point 36" horizontally to the edge of the open side.

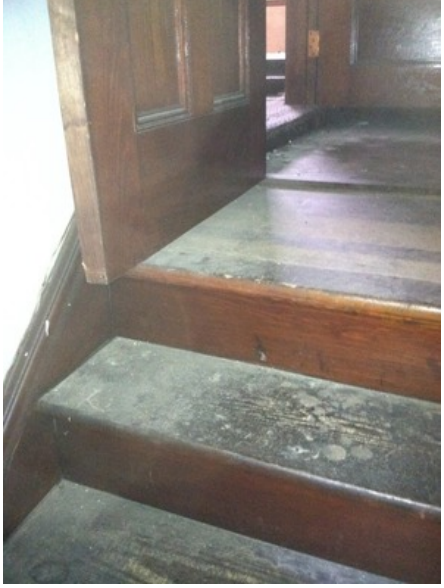
<p>3.1.a</p>	<p>Egress stairs from third floor are non-compliant:</p> <ul style="list-style-type: none"> • Non-compliant tread depth at 10” and riser height at 7.5” • Non-compliant winders to mezzanine and third floor • Door swing obstructs clear landing • Handrails are on one side only and are not continuous • Handrails lack extensions at top and bottom of run <ul style="list-style-type: none"> • <i>Request variance from MAAB to maintain existing handrails</i> • <i>Install an additional compliant handrail on outside wall of the stairs if feasible and approved by MHC.</i> 	<ul style="list-style-type: none"> • IBC 1009.4.2 Riser Height and Tread Depth: Stair riser height shall be 7 inches maximum. The riser height shall be measured vertically between the leading edges of adjacent of treads. Rectangular tread depths shall be 11 inches minimum measured horizontally between the vertical planes of the foremost projection of adjacent treads and at a right angle to the tread’s leading edge. • IBC 1009.4.3 Winder Treads: Winder treads are not permitted in means of egress stairways except within a dwelling unit. • IBC 1009.5 Stairway Landings: There shall be floor or landing at the top and bottom of each stairway. The width of the landings shall not be less than the width of stairways they serve.

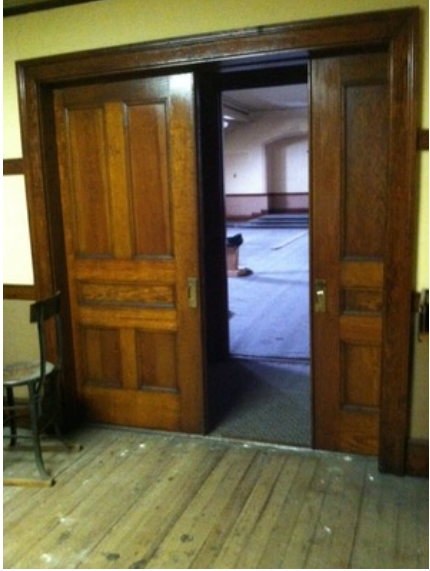
<p data-bbox="310 824 373 852">3.2.a</p>	<p data-bbox="968 285 1444 313">Entrance to masonic hall is non-compliant:</p> <ul data-bbox="968 354 1528 852" style="list-style-type: none"> <li data-bbox="968 354 1528 381">• 6' pocket door to masonic hall is non-compliant. <li data-bbox="968 824 1304 852">• <i>Eliminate access to balcony.</i> 	<ul data-bbox="1549 285 2043 381" style="list-style-type: none"> <li data-bbox="1549 285 2043 381">• IBC 1008.1.2 Door Swing: Egress doors shall be of the pivoted or side-hinged swinging type.
