Brookfield Town Hall, 6 Central Street, Brookfield, MA 01506

Phased Access Improvement and Re-Use Study

Final Report

June 1, 2014, rev. 7/1, 2014

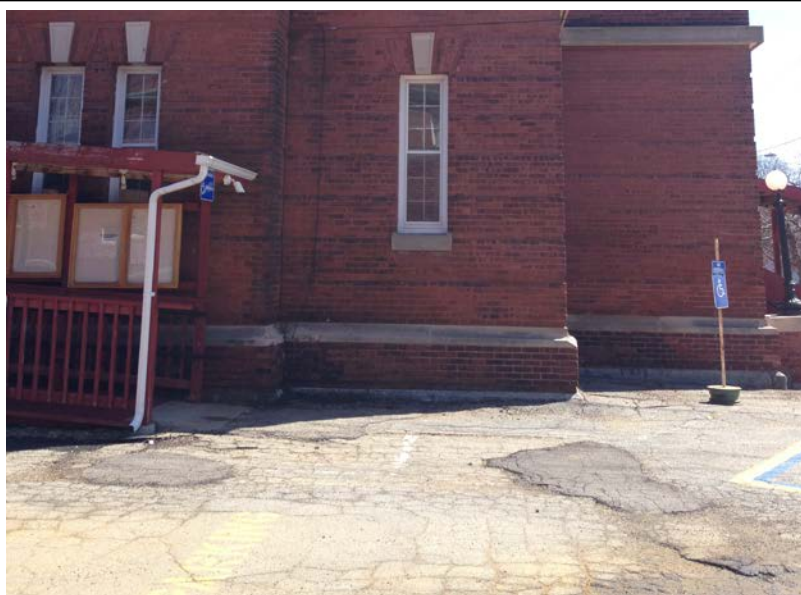
The asphalt paving around the building is generally deteriorated, frost heaved, patched and uneven posing a tripping hazard for pedestrians. On the North side of the building the paving has been ground up and a gravel like surface extends roughly 25 to 30 feet from the building.

Paving surfaces are deteriorated

6. Drainage and subsequent water infiltration:
Correct drainage issues and water penetration by regrading to slope grade away from building and installing new catch basins and positive drainage to storm sewer.
7. Paving surfaces:
Regrade and repave asphalt paved areas and delineate new accessible parking spaces.
8. Walkways:
Regrade and repave asphalt and concrete paved walks to provide even surface with compliant slopes of less than 5% running and less than 2% across.

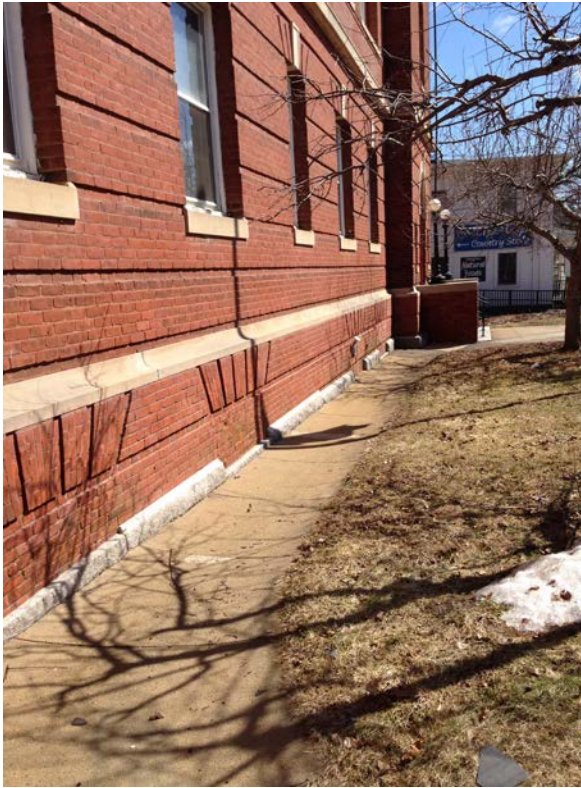
The combination of slope, paved surface and copious roof drainage without gutter and downspout collection results in accumulation of water against the building and subsequent seepage through the foundation walls and up through the basement floor slab. This is particularly troublesome on the West and South sides where water is trapped against the building. There has been an attempt on the South side to collect the water into a storm drain, but the collection point is too close to the building edge and the storm drain is undersized. In addition, snowfall from the roof builds up and drains back to the paved drainage swale against the building.

South face drainage

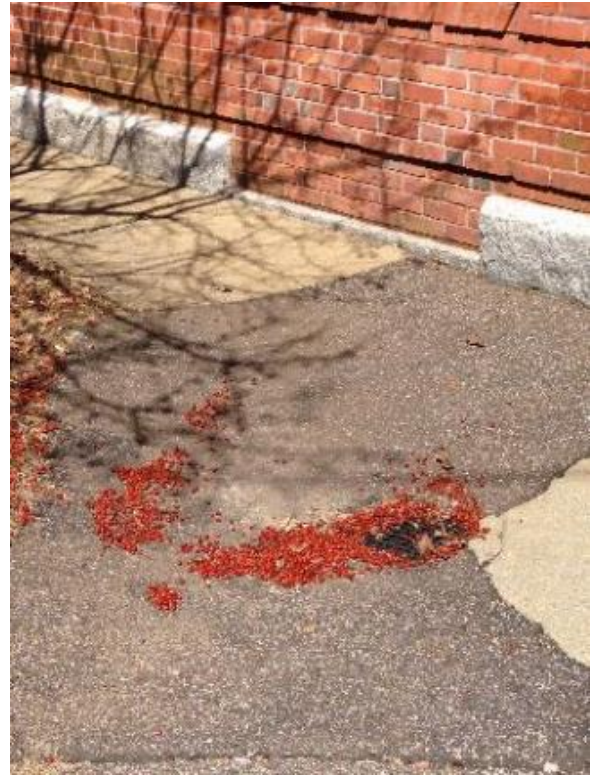
Storm drain at south face drainage

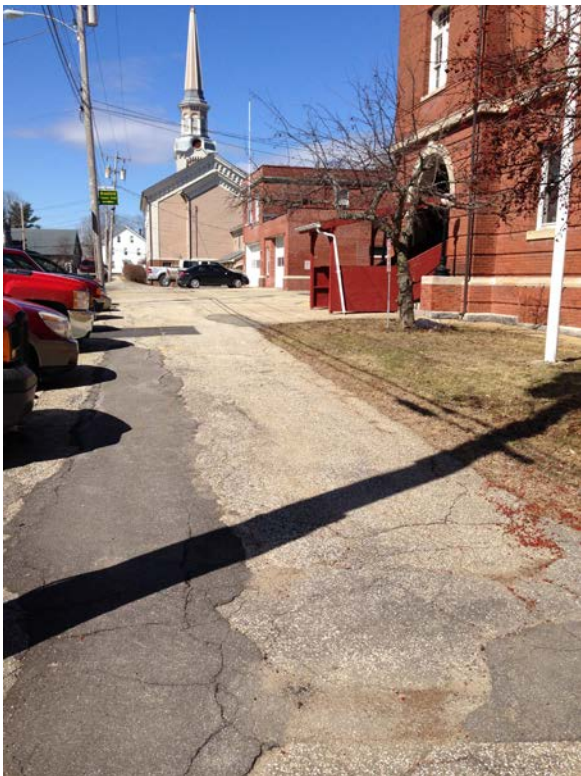
Walkways consist of an asphalt paved sidewalk in deteriorated and uneven condition with similarly poor asphalt walks leading to the two front entrances. On the east end there is a steeply sloped, heaved and uneven concrete walk that leads from the front corner of the building to a basement side entrance. All the walks are deteriorated and pose a severe tripping hazard.

Walkways are deteriorated: Patched and uneven sidewalk at front of building.

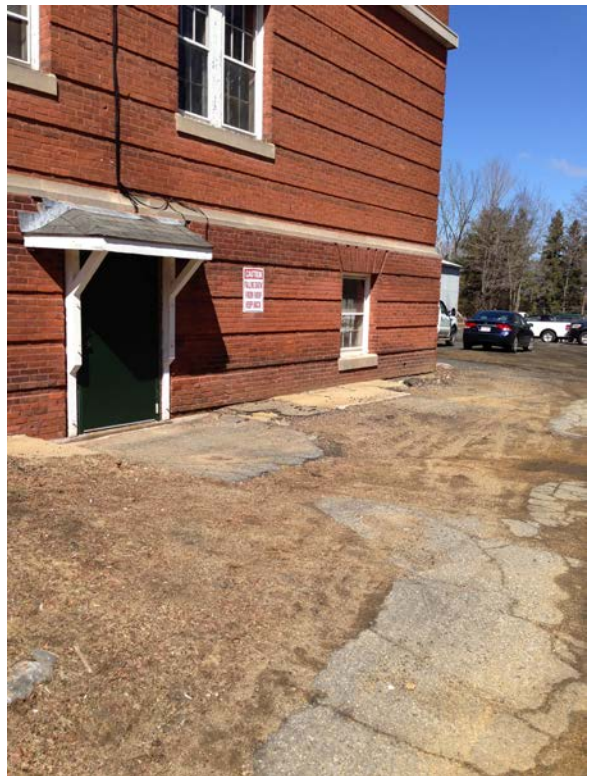
Walkways are deteriorated and dangerous: Asphalt paving and concrete walk at side service entrance.

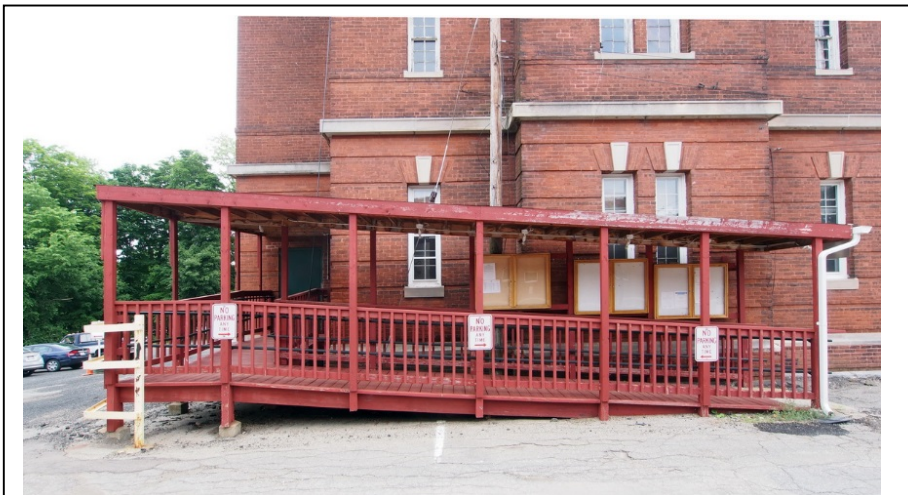
Ramp entrance on west end. Wood ramp is aged, but functional.

- Repairs and adjustments to the existing ramp to bring it into full compliance:**
The existing ramp is functional, but is in need of some repair to insure that the decking surface is even and without level changes, that the railings are secure, and that the entrance is operable by a person in a wheel chair.

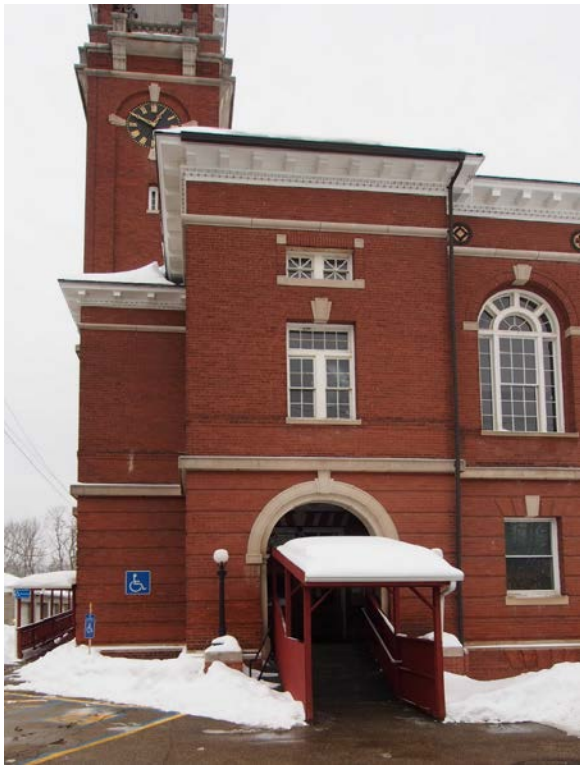
Main, front entrance with awning obscuring entrance and stair handrails

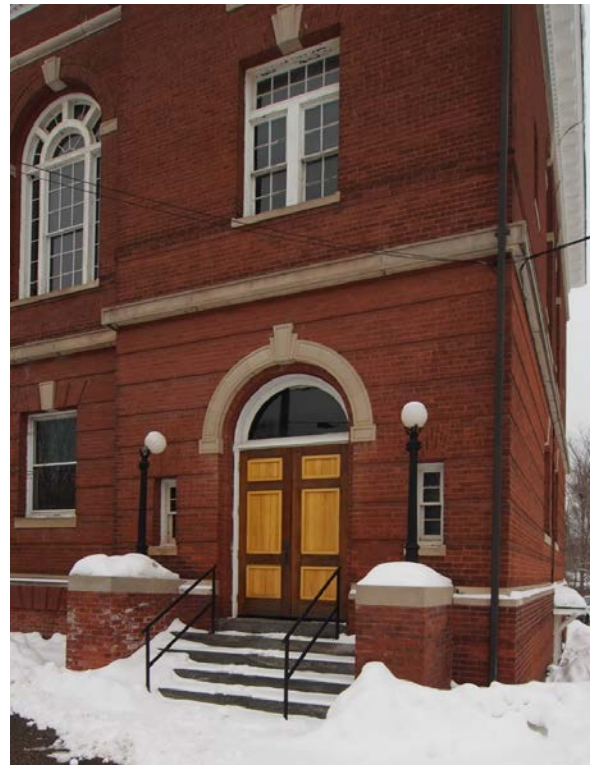
Secondary, front entrance. Doors swing out with no landing at top of stairs.

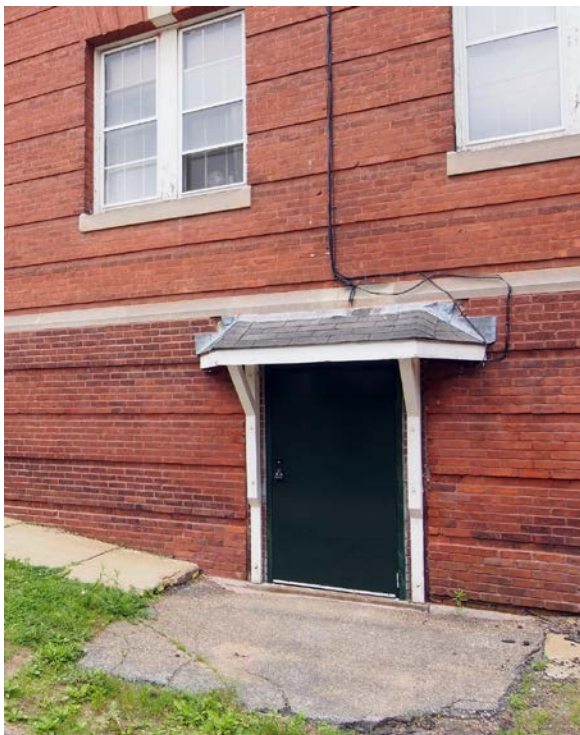
A single-door entrance on the East end of the building opens into the basement. There is a small wood awning over the door. The approach is by a deteriorated and steep concrete walk from the front or by deteriorated asphalt paving from the side drive. The door opening itself is very low and enters into the building at 3 steps above finish floor with no landing. The interior steps interfere with egress up or down a set of stairs from the front entrance above.

East end entrance to basement showing low doorway and deteriorated walkway

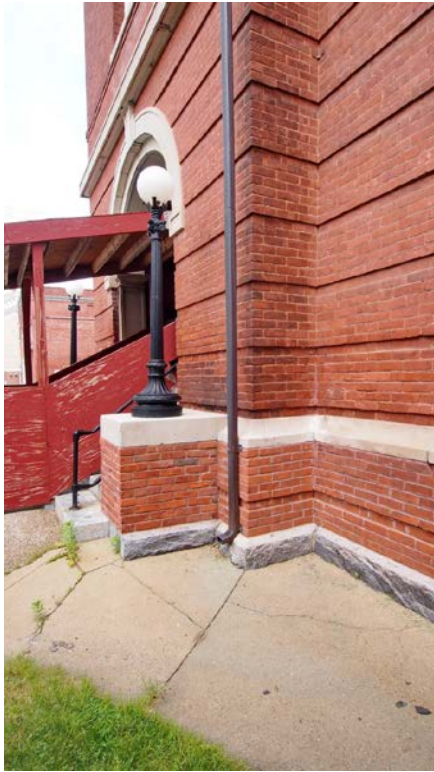
Detail of granite base, brick coursing and sandstone banding. Brick at lower levels has been repointed.

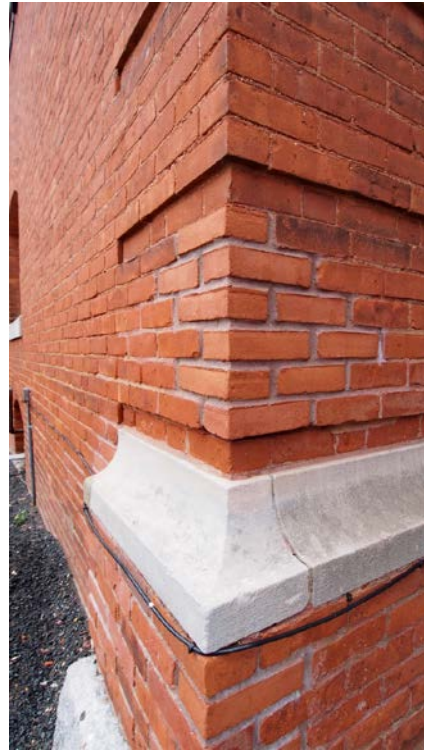
Example of brick repointing with inappropriate mortar. Such examples are rare.

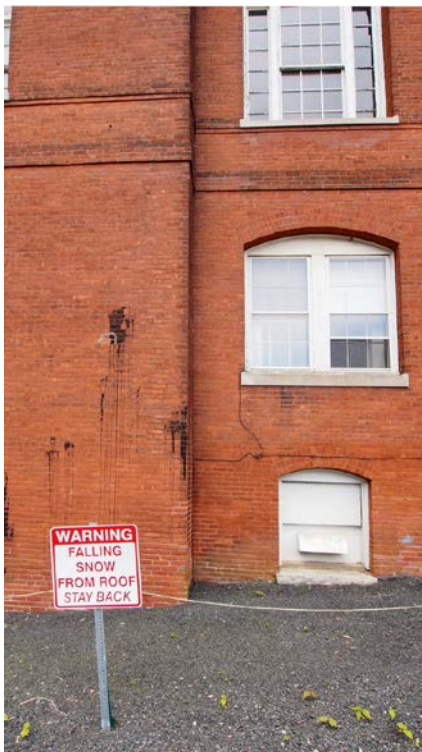
The brick and stone are in overall good condition. Mortar joints are overall tight and not severely weathered with a few exceptions, notably the clock tower and a few other areas at the upper reaches of the façade. Masonry along the base has been repointed in the past with careful attention to mortar matching. There is isolated efflorescence on the brick, particularly at the exterior stair side walls. The brick and stone are in need of cleaning.

Masonry in need of cleaning, North façade.

1. Exterior Materials and Finishes:
Repoint brick and caulk and paint wood trim work. Restore and re-fit double hung windows, caulk and paint.
2. Interior Materials and Finishes:
Maintain original existing materials and finishes to fullest extent. Restore altered and deteriorated materials and surfaces to their original condition, refinish woodwork, patch and paint plaster walls and ceilings. Re-use existing finishes such as wainscot in remodeled bathrooms. Where new finishes are to be included in renovation work select materials that are consistent with the historic character of the building.

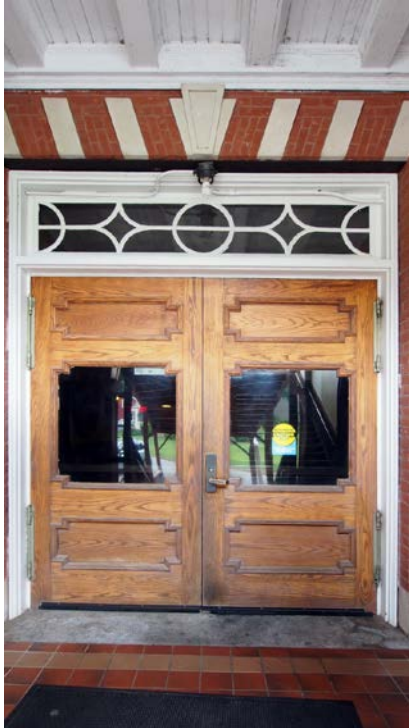
Front entry doors in recessed alcove. Masonry joints are tight, floor tile is in good conditions. Oak doors need to be refinished.

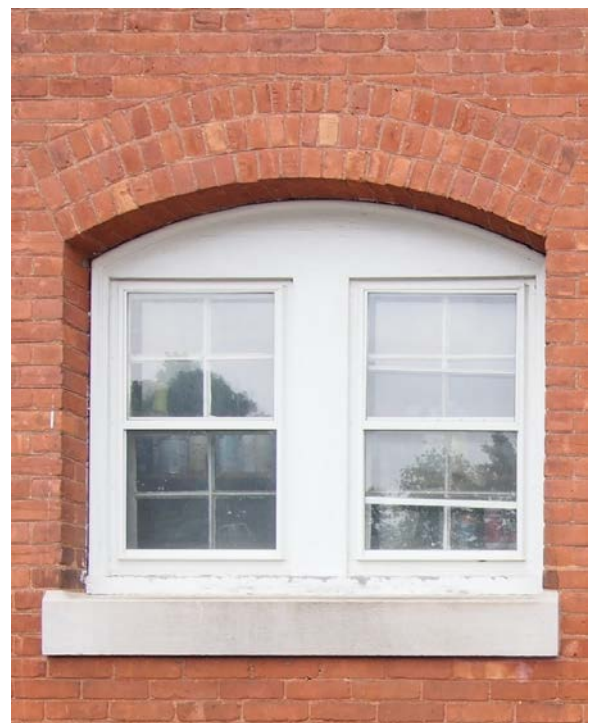
First floor windows with arched brick opening and sandstone sill. Storm windows have been applied over existing.

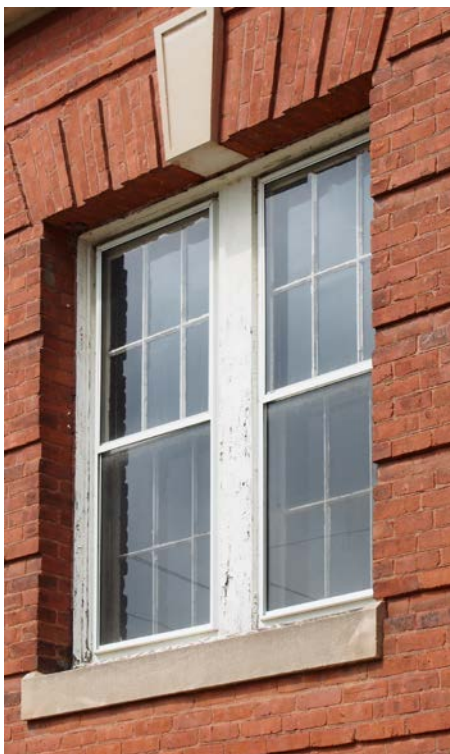
First floor windows in pedimented opening. Paint is peeling

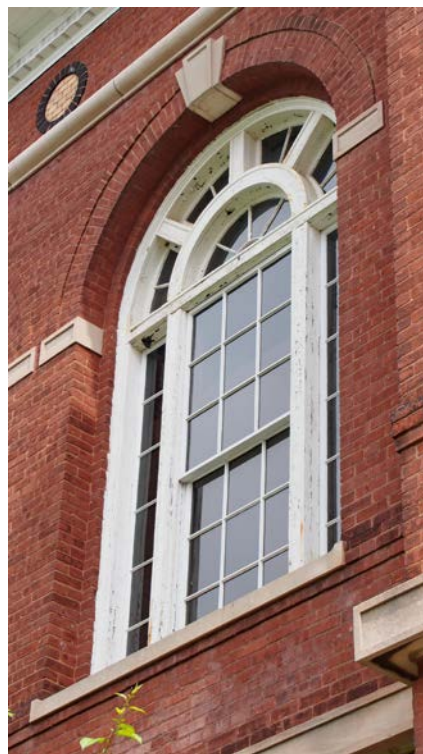
Windows are single pane double hung and fixed transoms without storms. Muntin pattern is 6 over 6. Sash is loose and needs refurbishing. No missing or broken glass was seen. Window sash, frames and trim are peeling badly and in need of paint.

Second floor auditorium windows, double hung with fixed sidelights and fixed arch top. Paint is peeling.

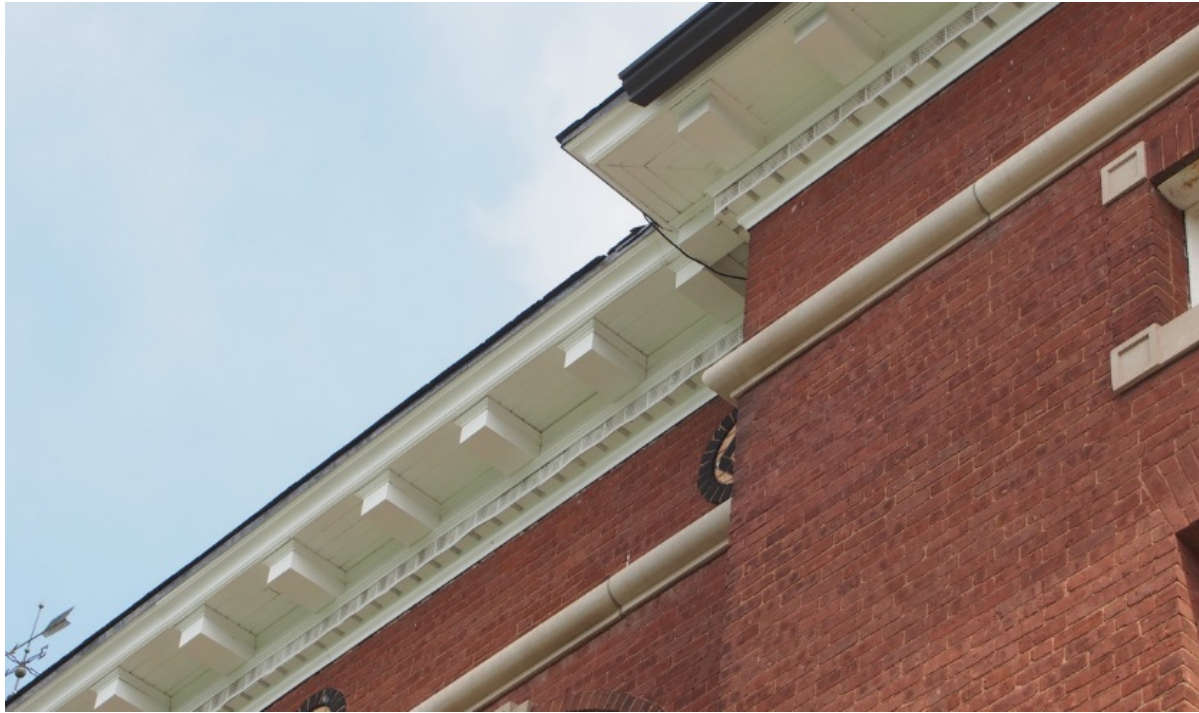
Painted soffit. Woodwork is in good condition, with paint holding up better than at windows.

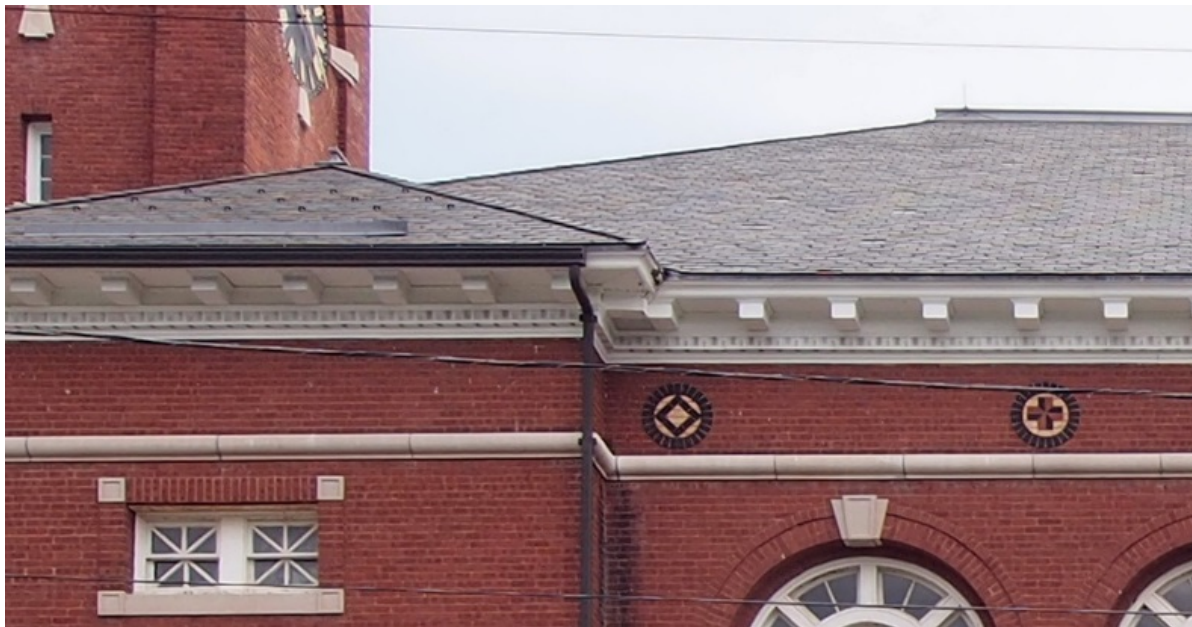
Slate roof showing snow deflector and guards over entrance. Additional, more effective snow guards and larger, copper gutter are recommended in lieu of the awning over the entrance below.

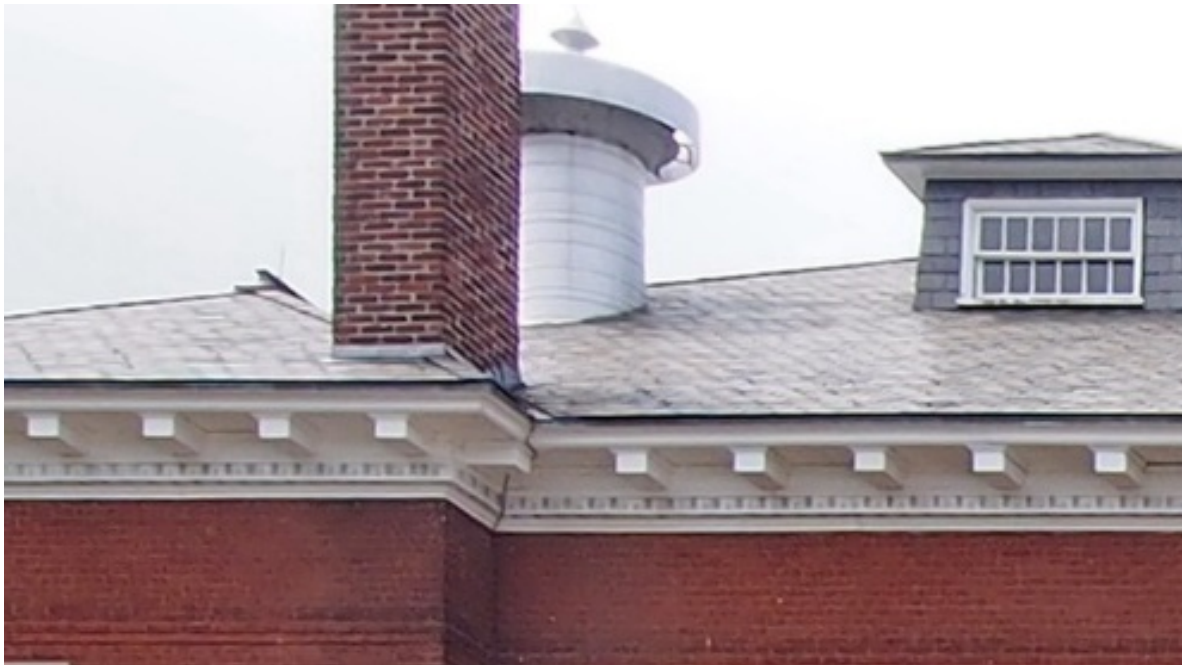
d. **Roof:** The roof is slate, recently replaced in 2012 . Over the course of the last winter, a total of 25 slates have come loose and fallen to the ground, discovered in the snow at the base of the building. It appears from an analysis of the slates that these are slates that have been adhered, rather than nailed, at flashing locations. The adhesion has failed in extremes of hot and cold and differential expansion of materials and the slates have come loose and slipped out. It is recommended that the slates be reinstalled with gasketed stainless steel nails and sealant.

Slate roof showing penetrations. It is believed that slate that has loosened and fallen from the roof is slate that has been adhered, rather than nailed and was located at areas where slate meets the flashings at roof penetrations and dormer sidewalls.

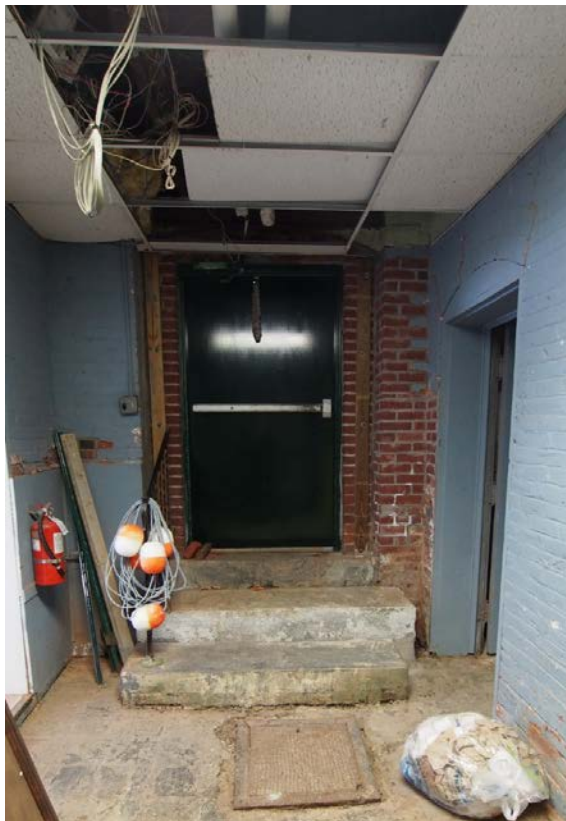
Basement hallway and egress/ service entry door. Note interior brick bearing walls. Stairs to exit intrude on egress to and from stairs to first floor on right.

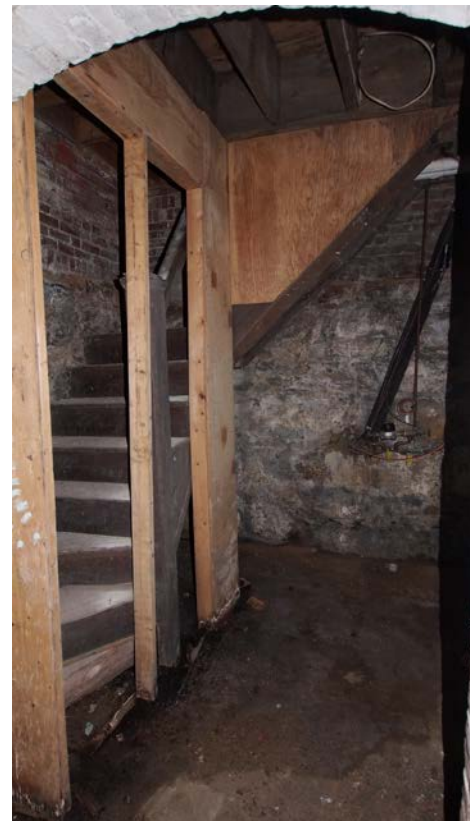
Stone foundation, brick knee wall and floor joists are visible. Former stairs that led to first floor, but are now closed off are located where new elevator is proposed to be installed. Signs of moisture are visible on the wall and floor.

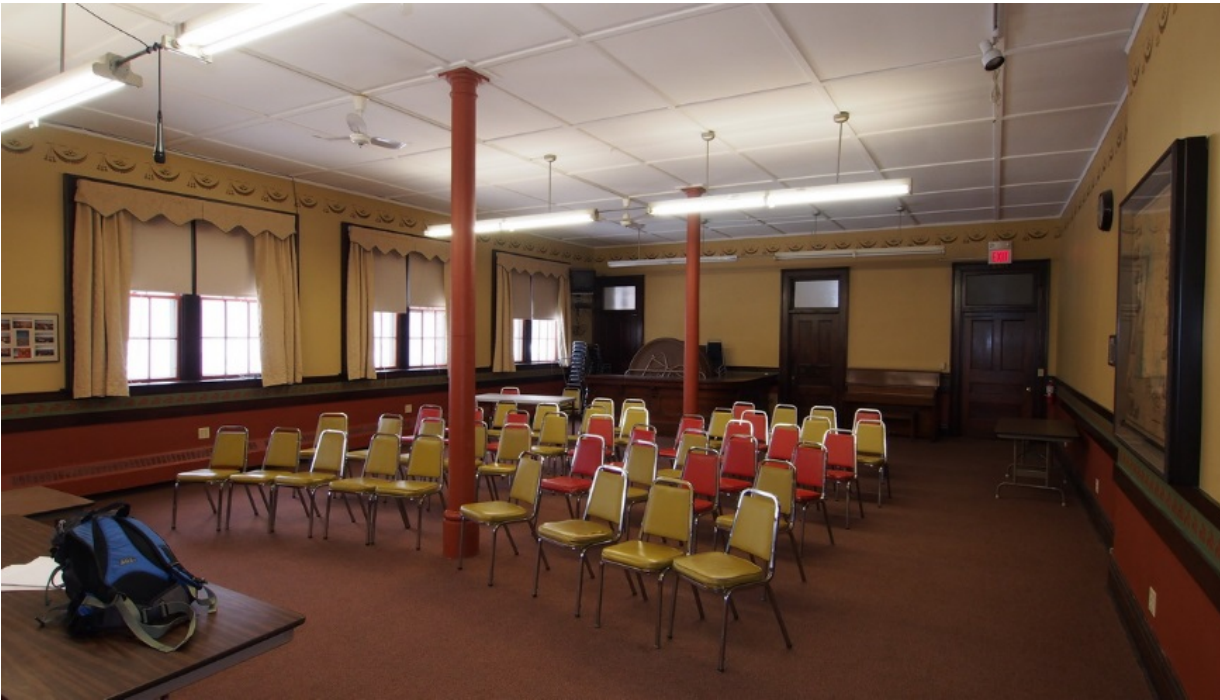
Banquet hall showing carpeted floor, lowered panel ceiling, steel bearing columns, plaster wall finish and chairrail.

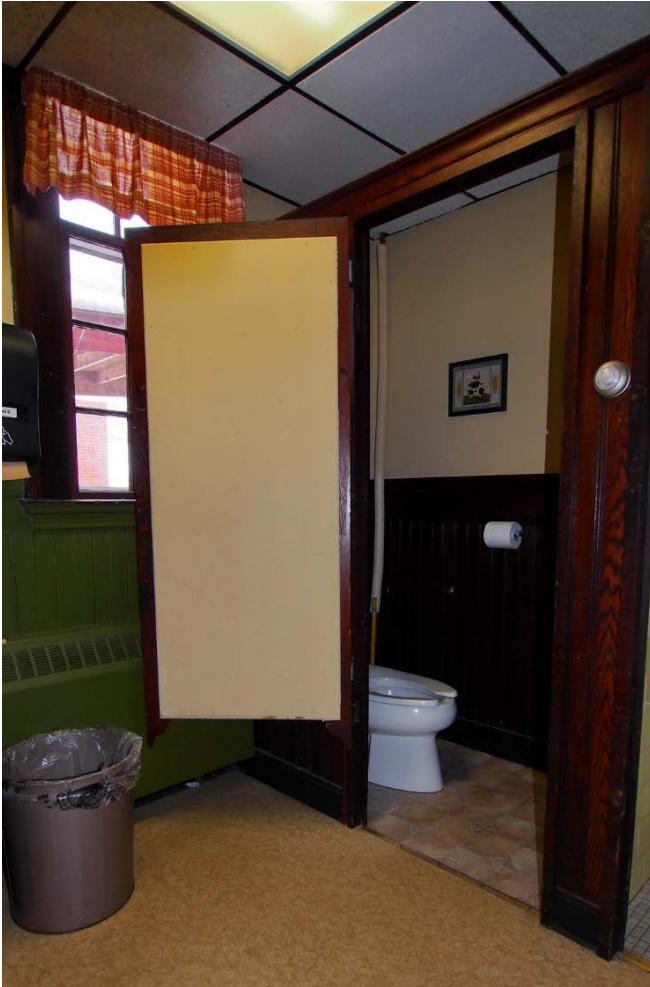
The toilet room on the first floor is the only functioning toilet room in the building, with a toilet, urinal and lavatory. It has a linoleum floor, beaded wood wainscot, plaster walls and a hung acoustical ceiling. The fixtures are not accessible and at 30" clear, the doorway is too narrow to admit a wheel chair.

The sole toilet room on the first floor has one toilet stall and one urinal. Ceiling is hung tile, floor is sheet vinyl.

- Renovate existing first floor toilet room to make it fully accessible:**
The existing toilet room, the only functioning toilet room in the building, is in deteriorated condition, lacks accessible fixtures and accessories, and is accessed by a door that is too narrow for passage of a wheel chair. Scope includes a full and complete renovation of the space, including new period linoleum flooring, patching of plaster and paint, new fixtures and accessories and bath ventilation and lighting. Existing wainscot and trim will be maintained and plaster patched, with all surfaces painted.

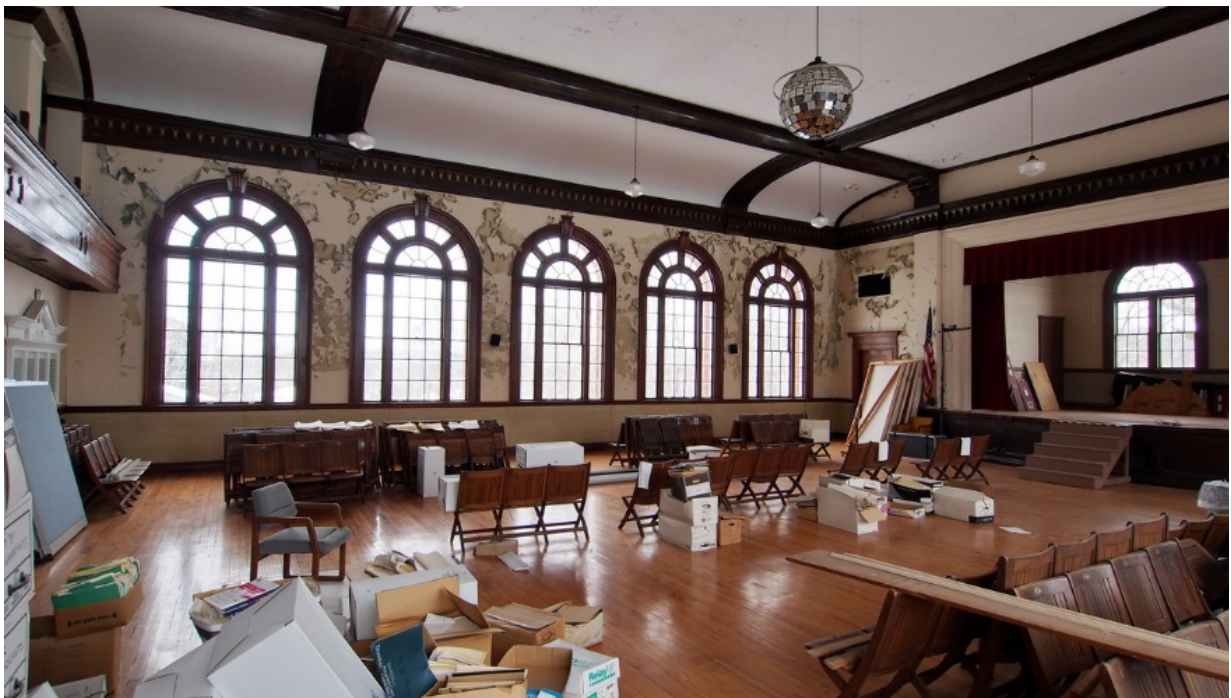
Second floor auditorium with balcony on left, stage on right. Peeling paint is visible on exterior walls.

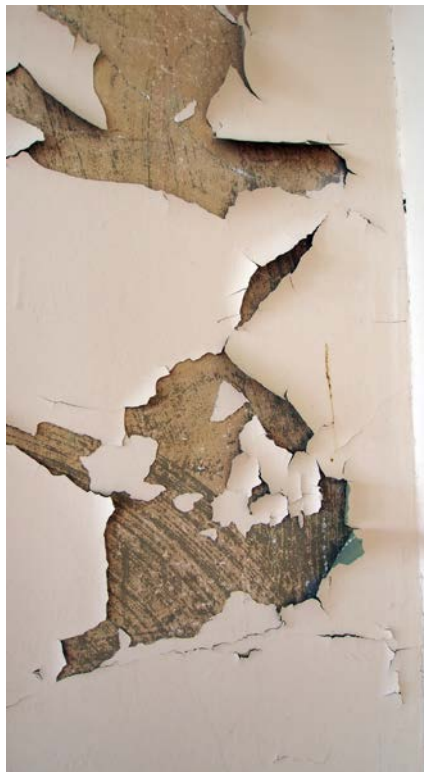
Peeling paint detail.

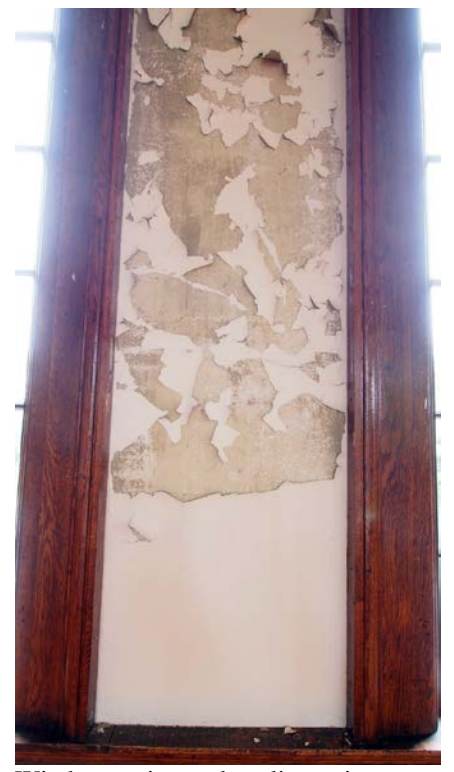
Window casing and peeling paint..

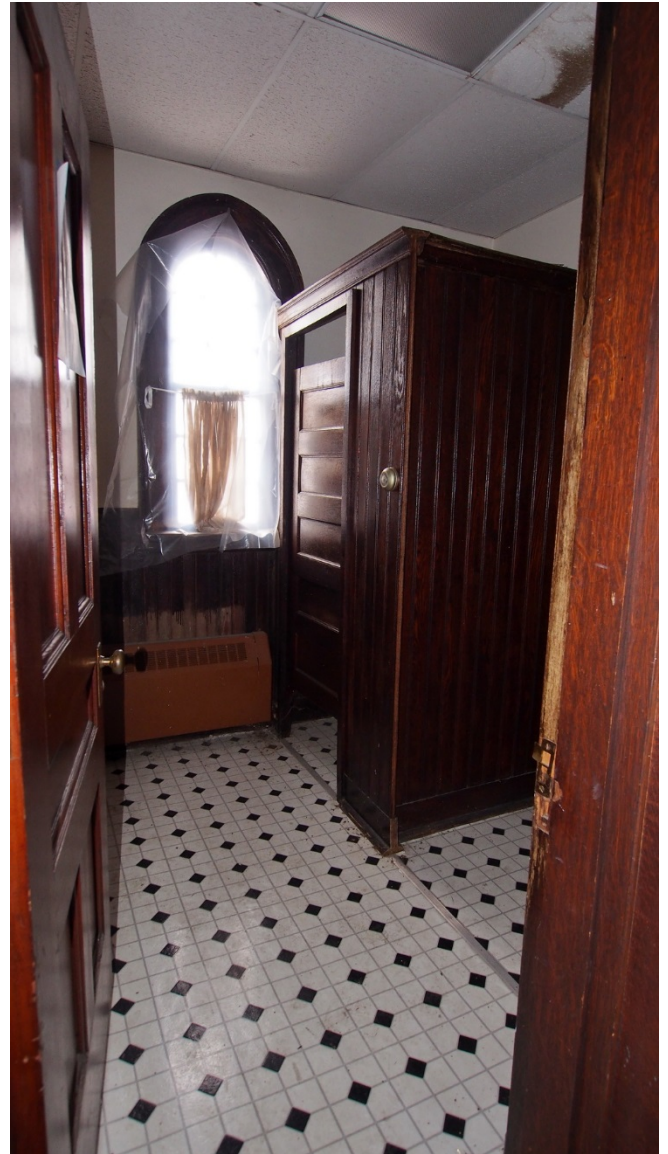
Decommissioned restroom on second floor. Restroom is at location of proposed elevator hoistway.

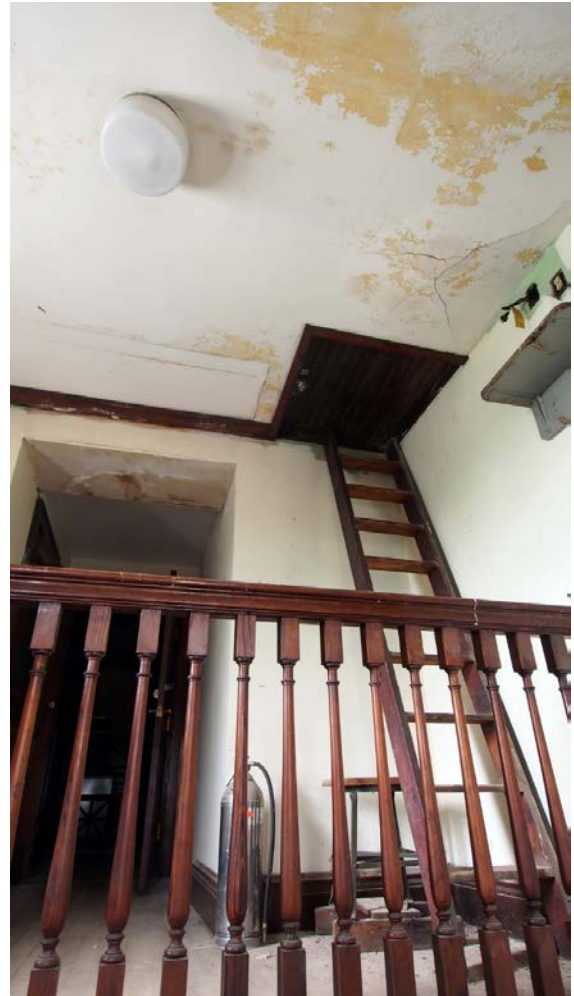
Third floor hall in clock tower showing ladder to clock level and damaged ceiling plaster and peeling paint.
