Brookfield Town Hall Prioritized Recommendations Cost Estimate

**Prepared By
Austin Design, Inc.**

Town Hall - Phased access improvement and re-use study

6 Central Street - Brookfield, Massachusetts

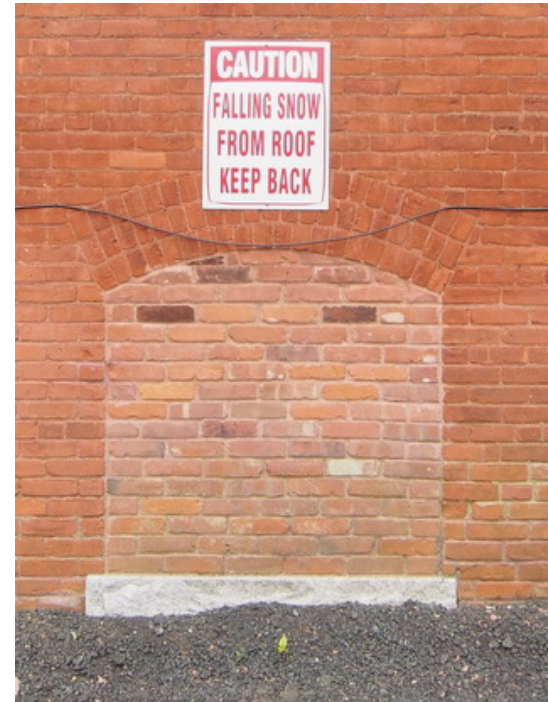
Window opening showing original arched brick lintel and brick infill.

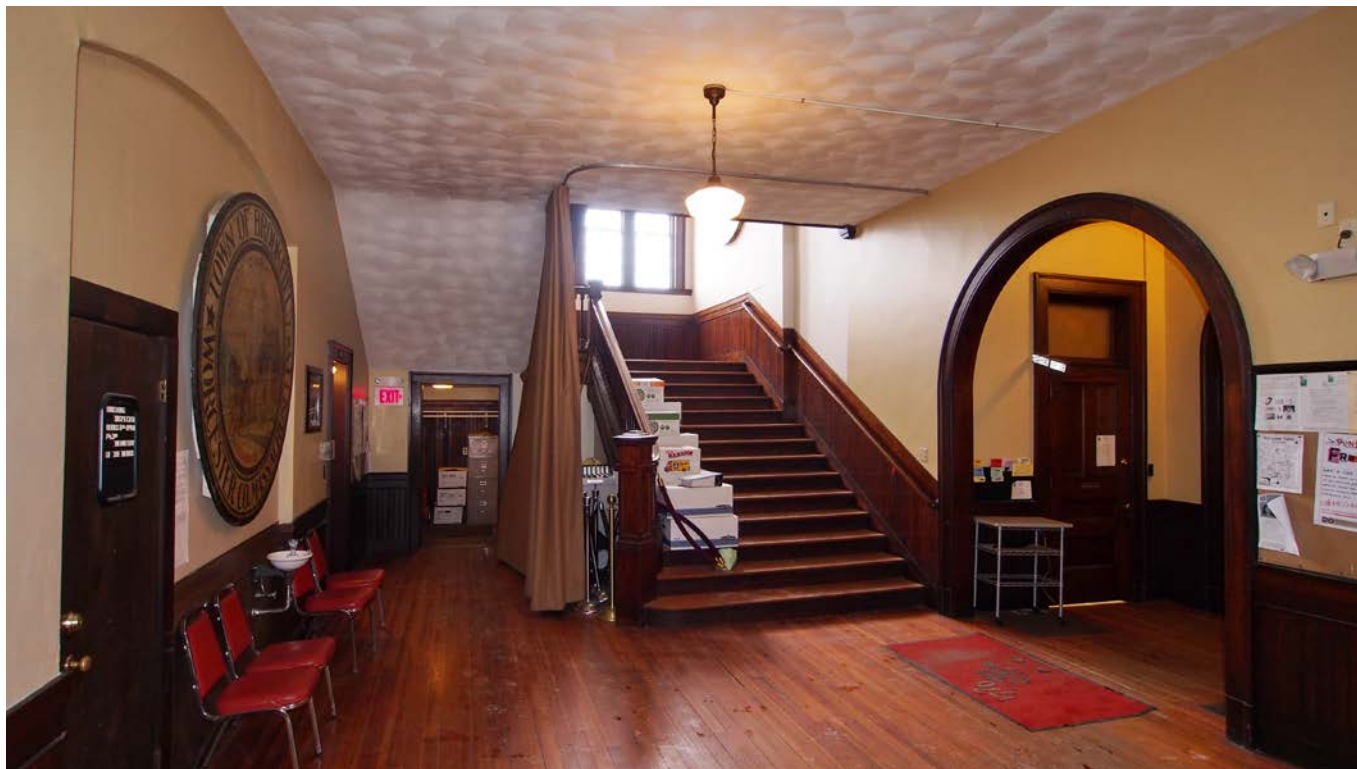
Main stair Hall with masonry partitions on side walls

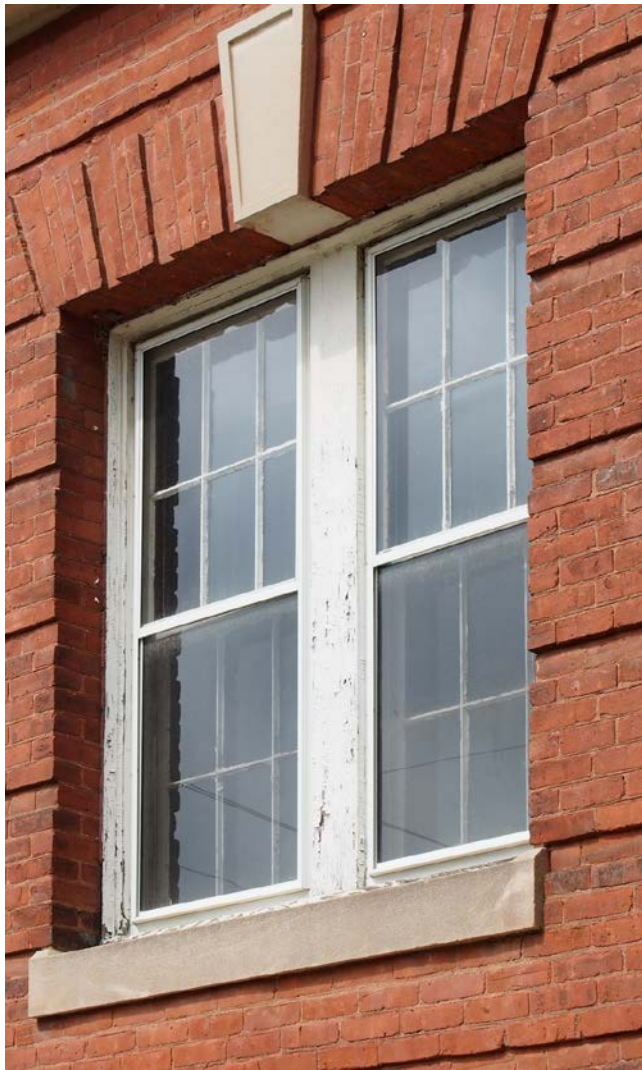
Pedimented brick opening at First Floor Window

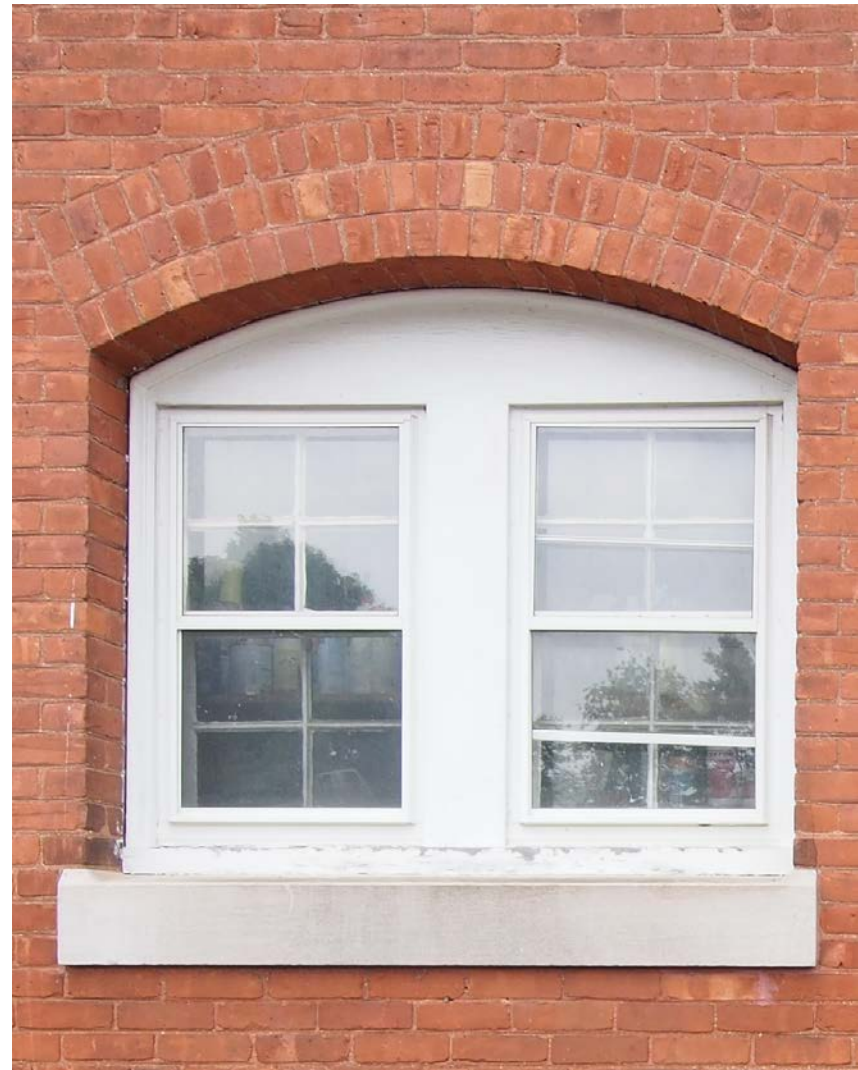
Arched brick opening at First Floor Window

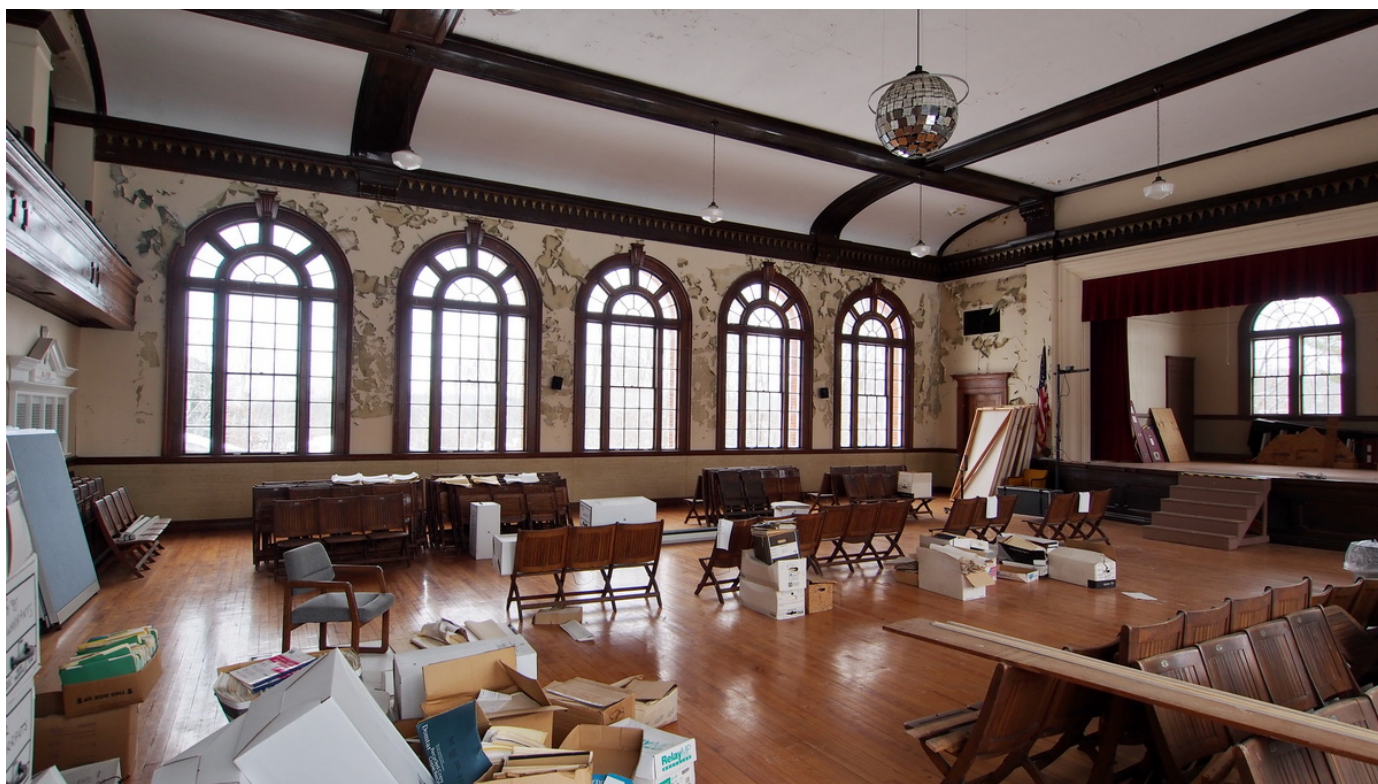
Main Auditorium space showing clear span of third floor – ceiling trusses.

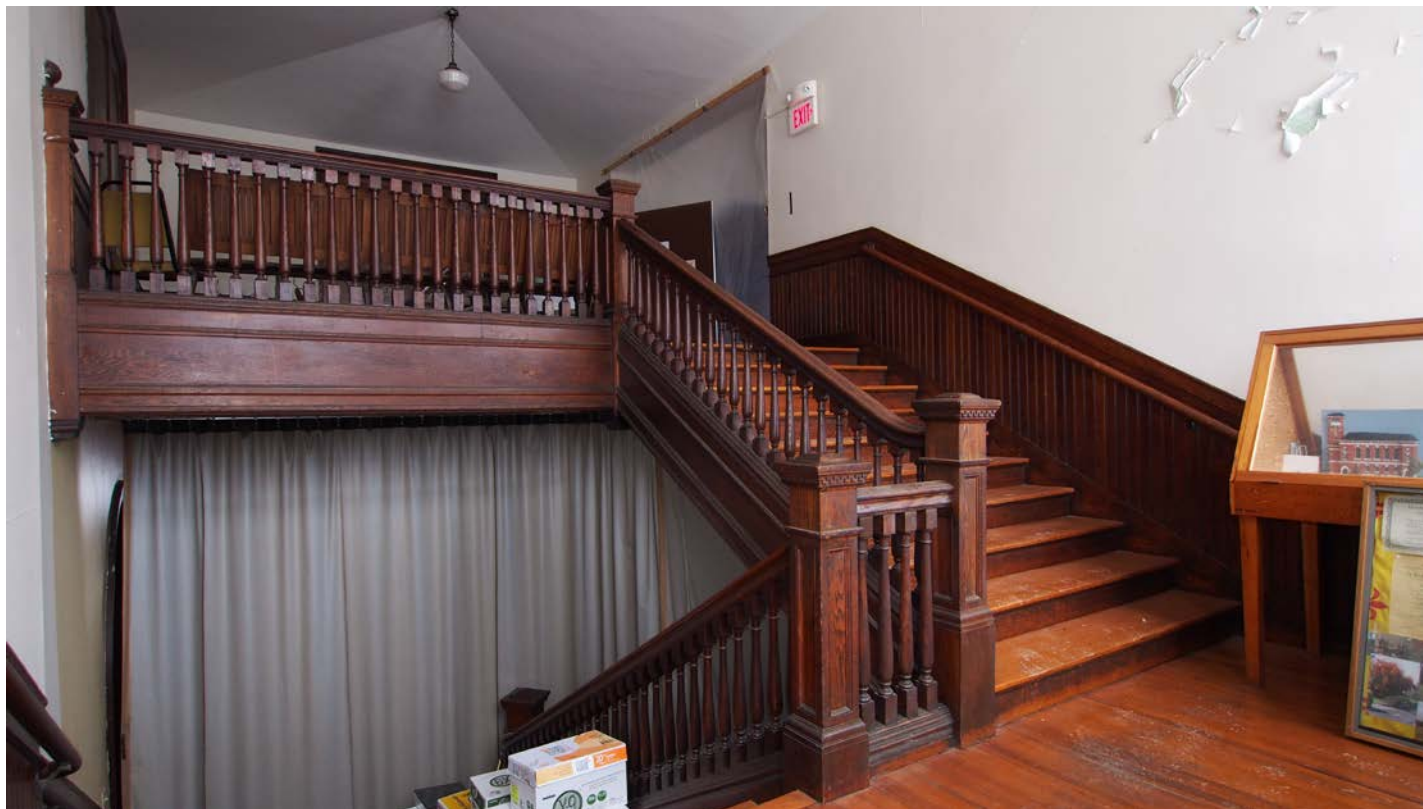
Main Stair Hall at second Floor showing hip ceiling hung from auditorium mezzanine structure above..

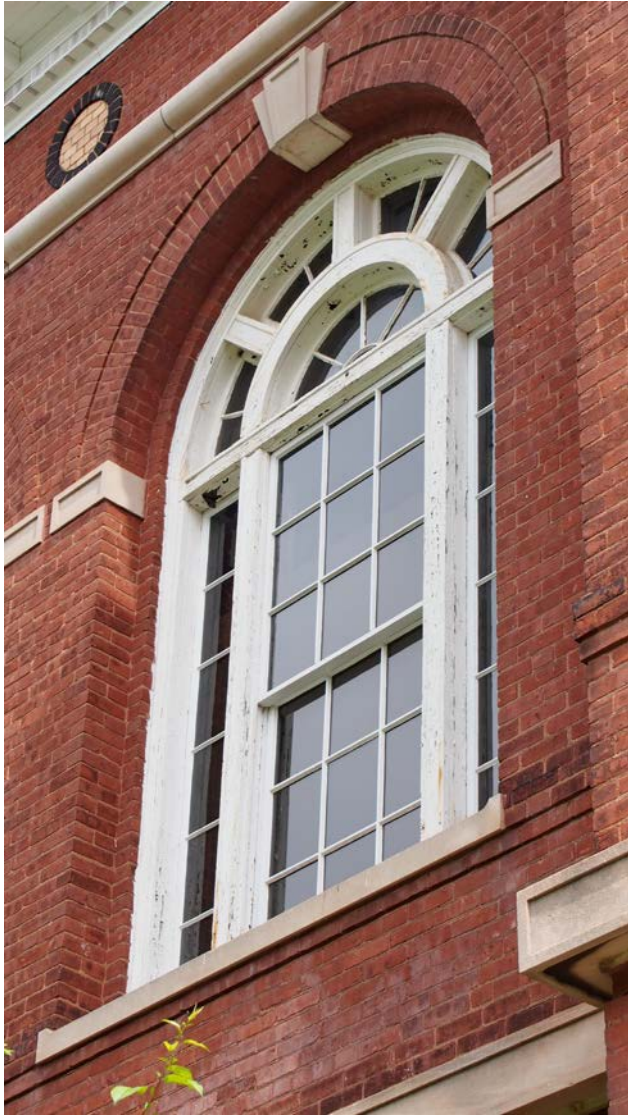
Arched brick opening at Second Floor Window

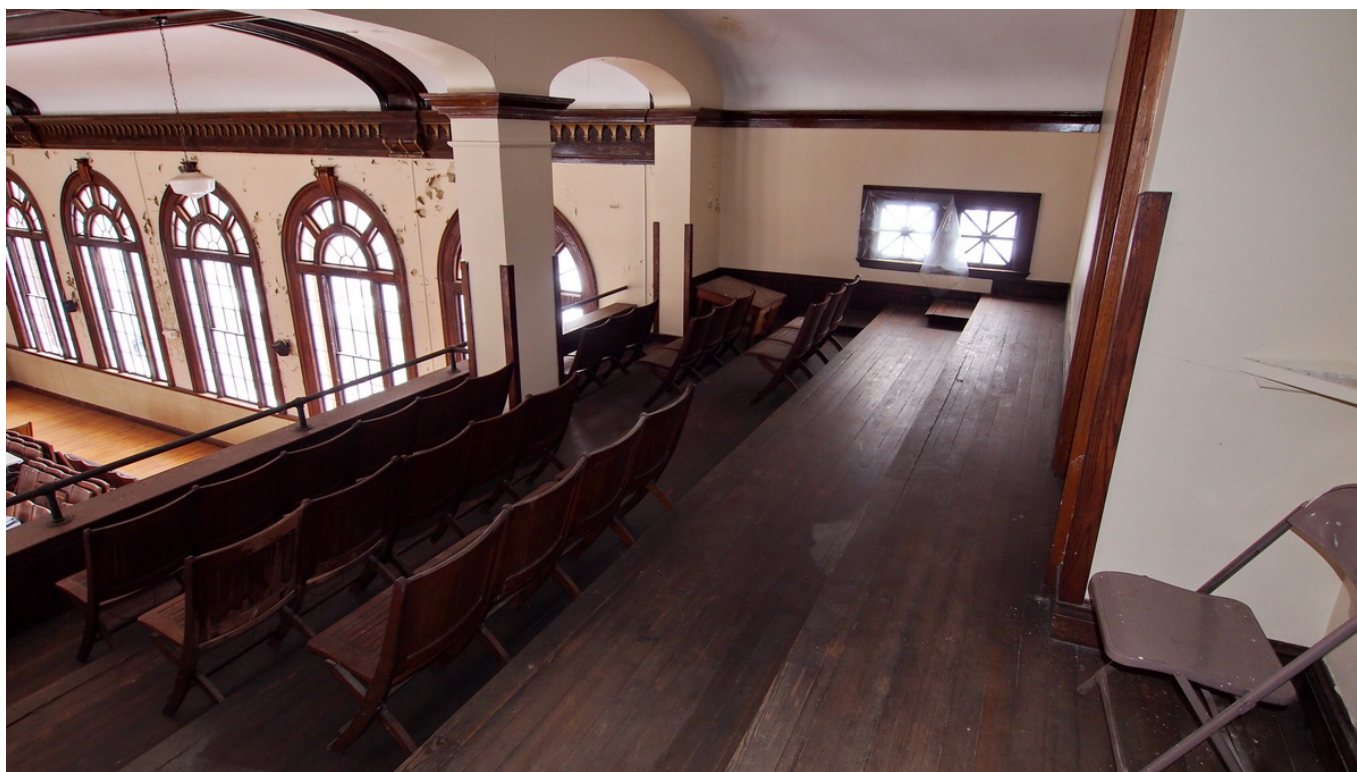
Main Auditorium balcony showing tiered levels built off the main floor framing.

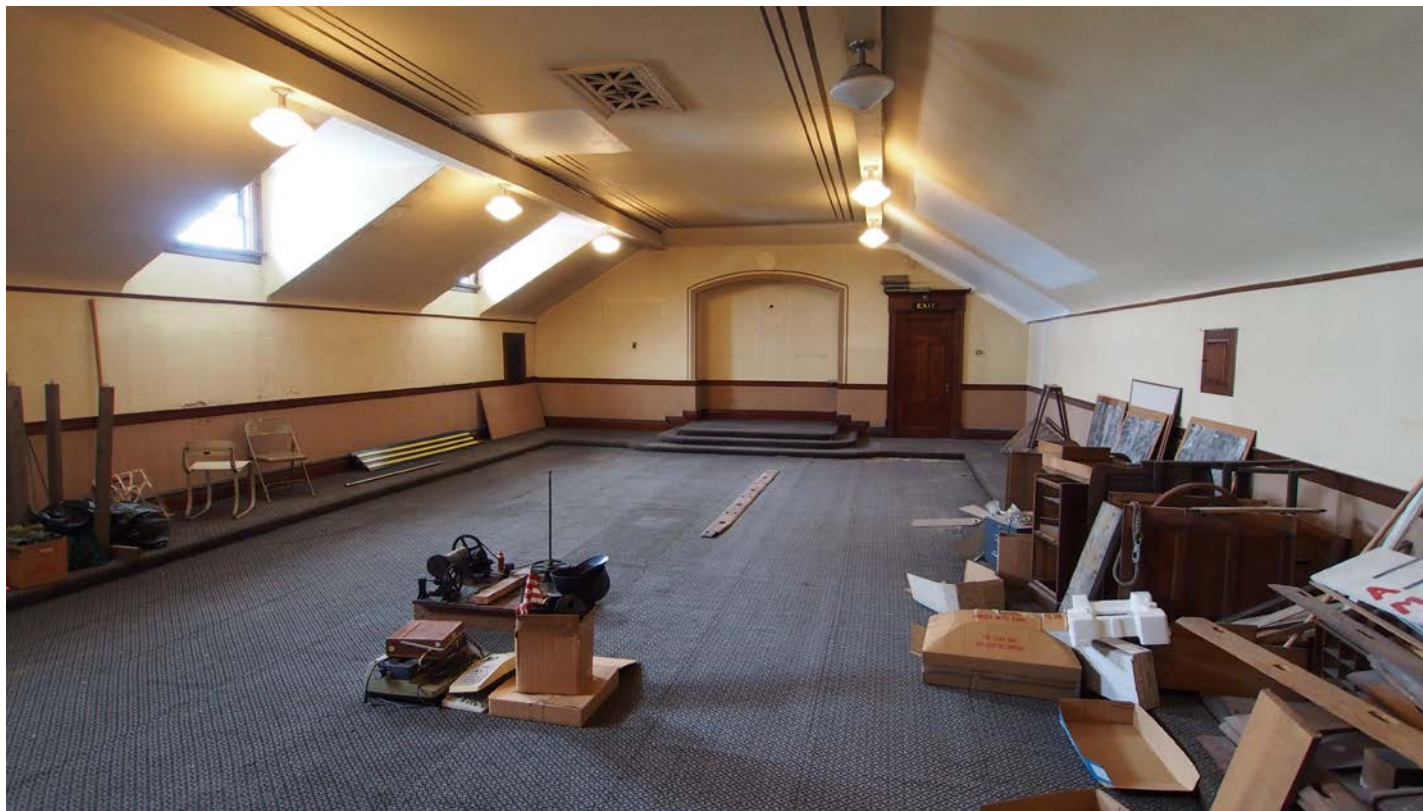
Main third floor space showing dormers and sloped rafter / ceiling plane.

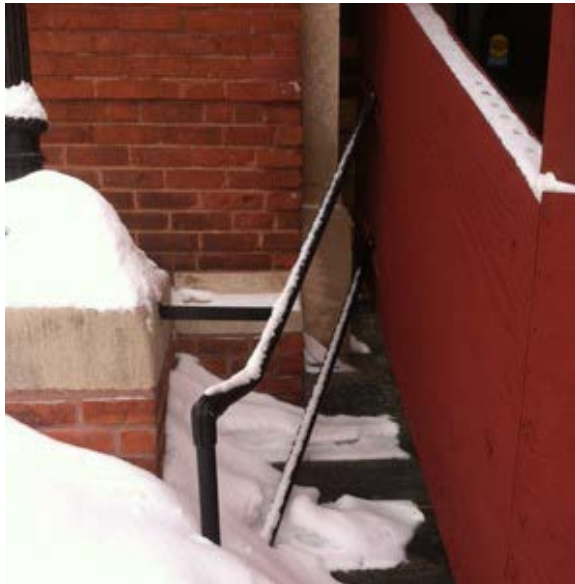
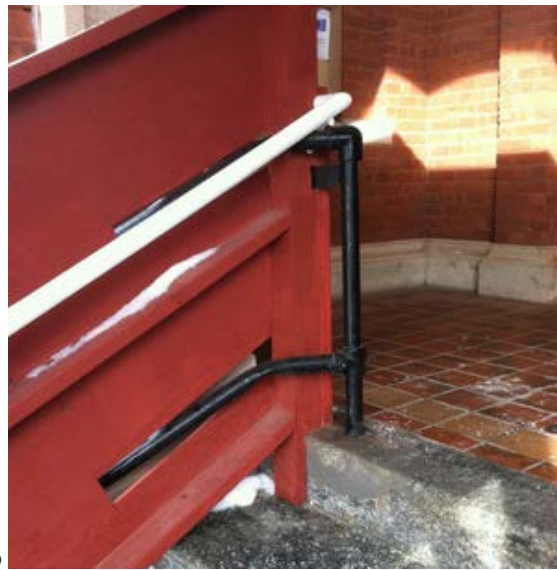
X.1.a

The main front entrance is not accessible:

- **521CMR 27.4 Stair Handrails:** Handrails shall comply with 27.4.1 Location, 27.4.2 Height, 27.4.3 Extensions, 27.4.4 Size, 27.4.5 Shape, 27.4.6 Surface, 27.4.7 Clearance, 27.4.8 End Condition.

- *Remove constructed awning and install compliant handrails on both sides of stair.*

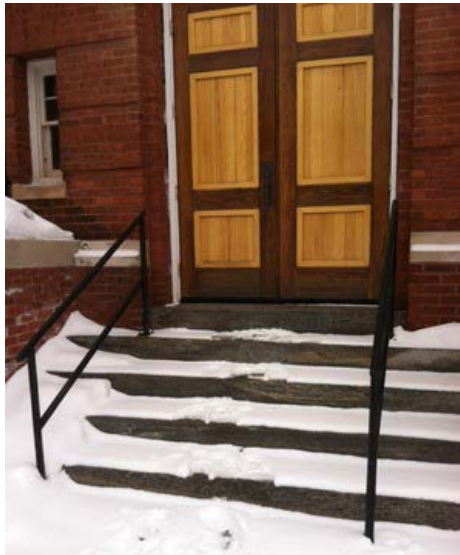
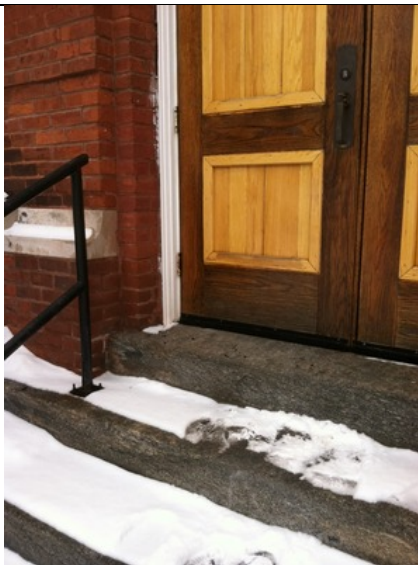
X.2.a

The secondary front entrance is not accessible:

- 521CMR 25.1 Entrances: All public entrance(s) of a building or tenancy in a building shall be accessible.
- 521CMR 25.6, 41.1.3.c Inaccessible entrances shall have directional signage to indicate the route to the nearest accessible entrance.
- 521CMR 26.6 Maneuvering Clearance: A minimum clear floor area shall be provided on both sides of all doors and gates.
- 521CMR 27.4 Stair Handrails: Handrails shall comply with 27.4.1 Location, 27.4.2 Height, 27.4.3 Extensions, 27.4.4 Size, 27.4.5 Shape, 27.4.6 Surface, 27.4.7 Clearance, 27.4.8 End Condition.

- *Add signage indicating route(s) to accessible entrance(s).*
- *Install compliant handrails.*

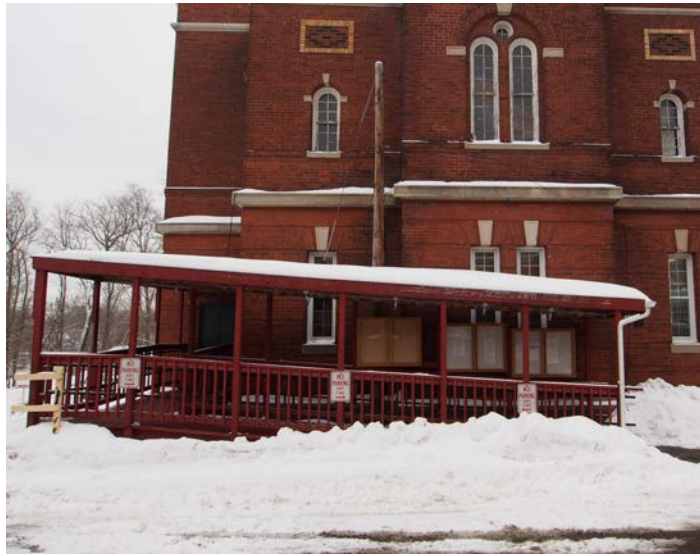
X.3.a

Entrance ramp is technically compliant but leads to a non-compliant doorway off a back hall beneath the main interior stairs

- Entrance ramp leading to rear/side entrance is built of wood and is in deteriorated condition
- Surface is uneven
- Slope?

- *Remove/rebuild ramp?*

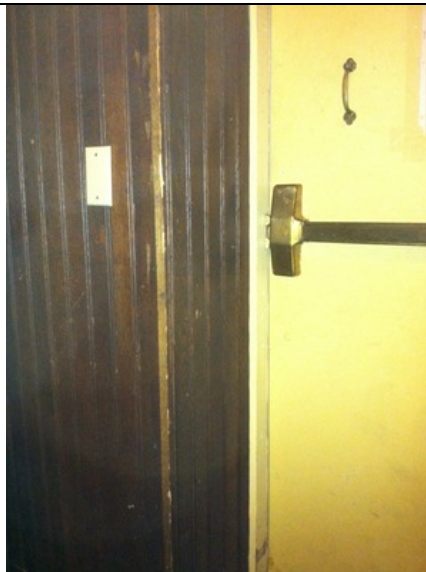
X.3.b

Ramp entrance door is non-compliant:

- *Add power door openers to doors.*

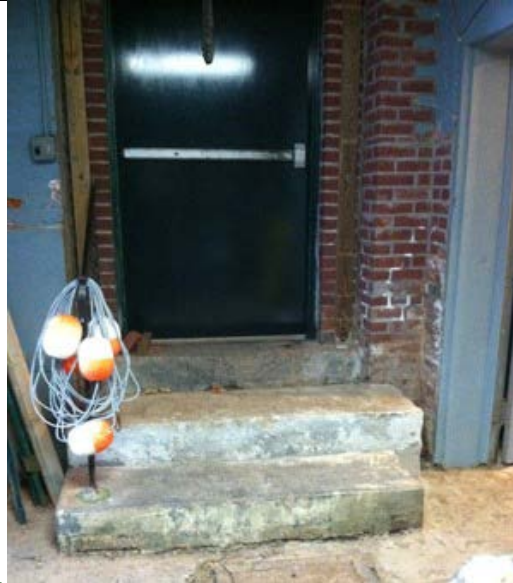
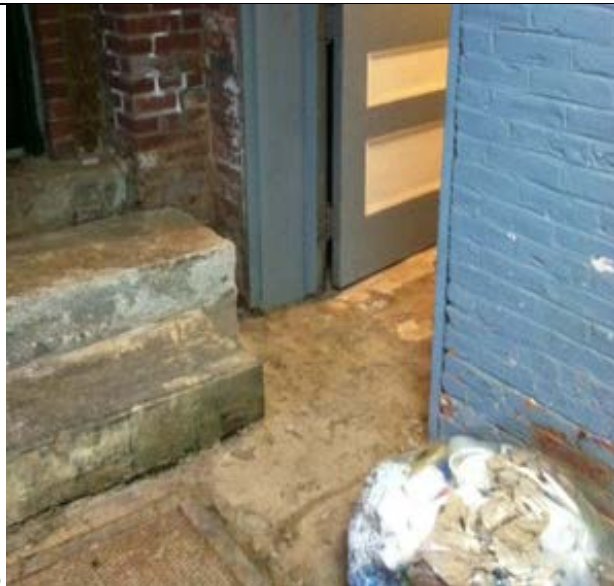
X.4.a

East Side Basement Entrance is non-compliant:

- Stairs protrude into doorway to egress stair.
- Floor surface is in poor condition
- There is no landing level with the door.
- Stair treads and risers are non-compliant with inconsistent riser heights over 8”.
- Handrails are on only one side and lack extensions.

- **521CMR 20.1 General:** An accessible route shall provide a continuous unobstructed path connecting accessible spaces and elements inside and outside a facility. Accessible routes may not include stairs, steps or escalators, even if the stairs and steps are required to be accessible under 521 CMR.
- **521CMR 20.6 Protruding Objects:** Objects shall not reduce the clear width of an accessible route or maneuvering space (see Fig. 20c) and must comply with 521CMR 20.6.1.
- **521CMR 20.8 Surface Textures:** The surface of an accessible route shall comply with 521CMR 29.00 Floor Surfaces.

- **521CMR 25.1 Entrances:** All public entrance(s) of a building or tenancy in a building shall be accessible.
- **521CMR 26.6 Maneuvering Clearance:** A minimum clear floor area shall be provided on both sides of all doors and gates.
- **521CMR 27.2 Treads and Risers:** On any given flight of stairs, all steps shall have uniform riser heights and uniform tread widths. See Fig. 27a.
- **521CMR 27.4 Stair Handrails:** Handrails shall comply with 27.4.1 Location, 27.4.2 Height, 27.4.3 Extensions, 27.4.4 Size, 27.4.5 Shape, 27.4.6 Surface, 27.4.7 Clearance, 27.4.8 End Condition.

- *Construct new accessible entrance to basement level as part of renovations to basement.*

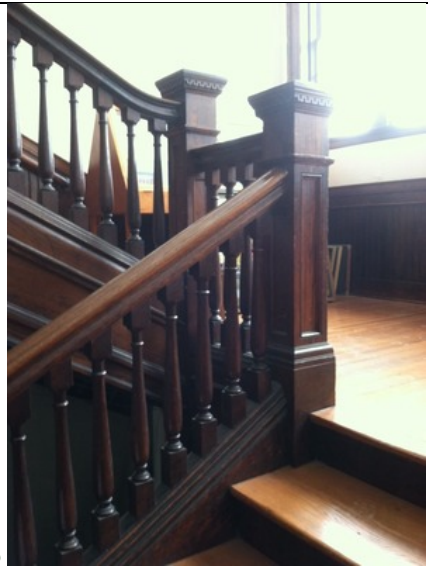
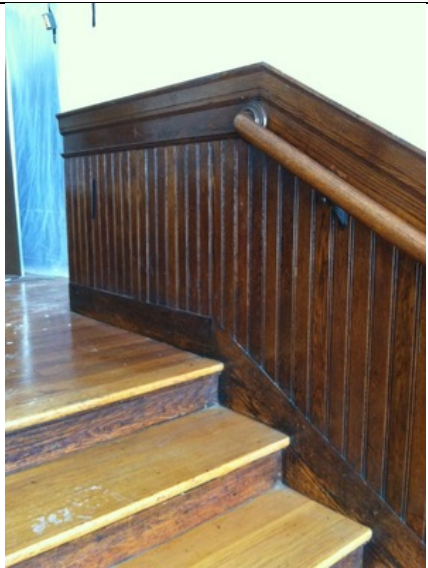
<p>3.1.a</p>	<p>Monumental stair is non-compliant due to:</p> <ul style="list-style-type: none"> • Non-compliant railings, size of handrail • Handrails lack extensions at top and bottom of run. • Gripping surface is interrupted and not continuous. • No rail on guard <ul style="list-style-type: none"> • <i>Request variance from MAAB to maintain existing handrails.</i> • <i>Install an additional compliant handrail on outside wall of the stairs if feasible and approved by MHC.</i> 	<ul style="list-style-type: none"> • 521CMR 27.4 Stair Handrails: Handrails shall comply with 27.4.1 Location, 27.4.2 Height, 27.4.3 Extensions, 27.4.4 Size, 27.4.5 Shape, 27.4.6 Surface, 27.4.7 Clearance, 27.4.8 End Condition, 27.4.9.

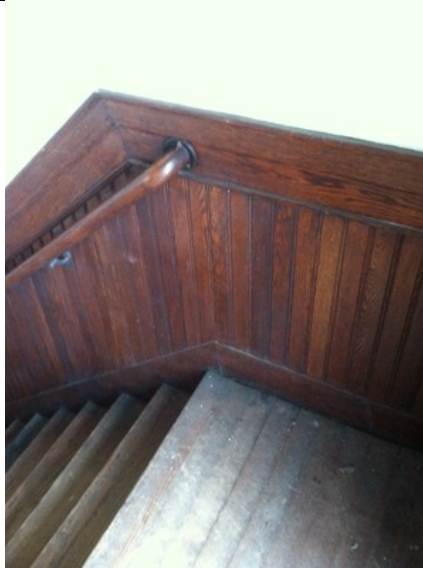
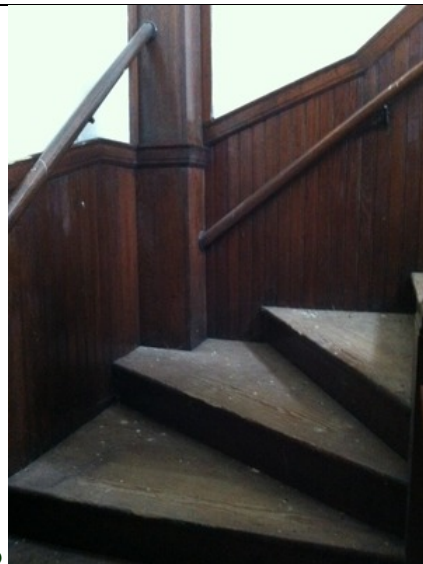
3.2.a

Stair to mezzanine and third floor is non-compliant due to:

- Non-compliant tread depth at 10” and riser height at 7.5”
- Non-compliant winders to mezzanine and third floor
- Handrails are on one side only and are not continuous
- Handrails lack extensions at top and bottom of run.
- Handrails are too large at 2 ¼”

- **521CMR 27.2 Treads and Risers:** On any given flight of stairs, all steps shall have uniform riser heights and uniform tread widths. See Fig. 27a.
- **521CMR 27.4 Stair Handrails:** Handrails shall comply with 27.4.1 Location, 27.4.2 Height, 27.4.3 Extensions, 27.4.4 Size, 27.4.5 Shape, 27.4.6 Surface, 27.4.7 Clearance, 27.4.8 End Condition, 27.4.9

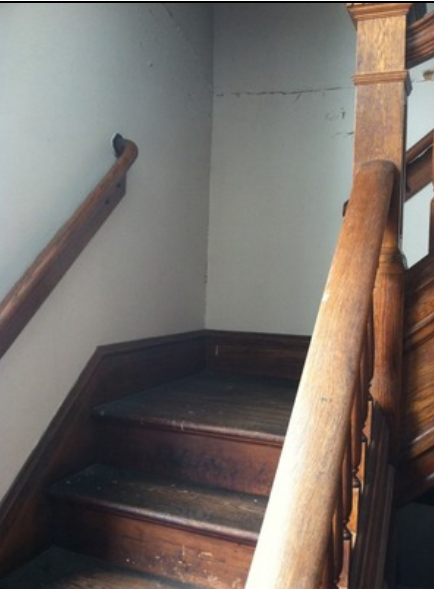
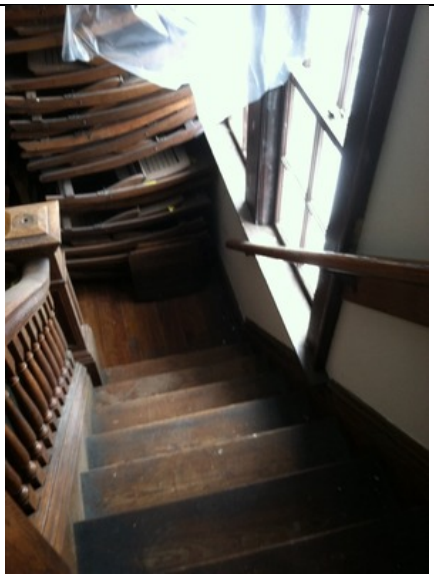
<p>3.3.a</p>

<p>Egress stair from balcony is non-compliant due to:</p> <ul style="list-style-type: none"> • Stair clear width reduced to 30" • Non-compliant tread depth at 10" and riser height at 7.5" • Handrails lack extensions at top and bottom of run • Non-compliant window at stair <ul style="list-style-type: none"> • <i>Request variance from MAAB to maintain existing handrails</i> • <i>Install an additional compliant handrail on outside wall of the stairs if feasible and approved by MHC.</i> 	<ul style="list-style-type: none"> • 521CMR 20.3 Width: An accessible route shall have a minimum clear width of 36 inches. • 521CMR 27.2 Treads and Risers: On any given flight of stairs, all steps shall have uniform riser heights and uniform tread widths. See Fig. 27a. • 521CMR 27.4 Stair Handrails: Handrails shall comply with 27.4.1 Location, 27.4.2 Height, 27.4.3 Extensions, 27.4.4 Size, 27.4.5 Shape, 27.4.6 Surface, 27.4.7 Clearance, 27.4.8 End Condition, 27.4.9.

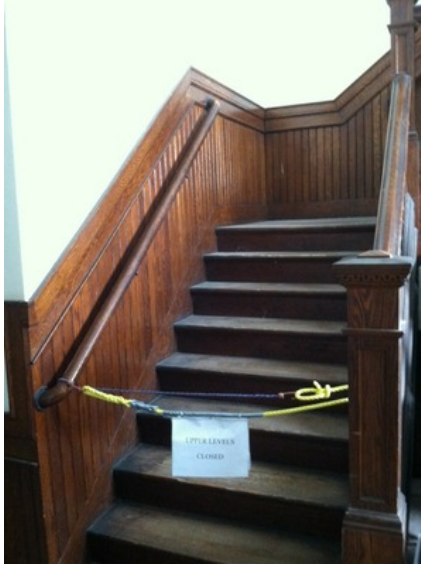
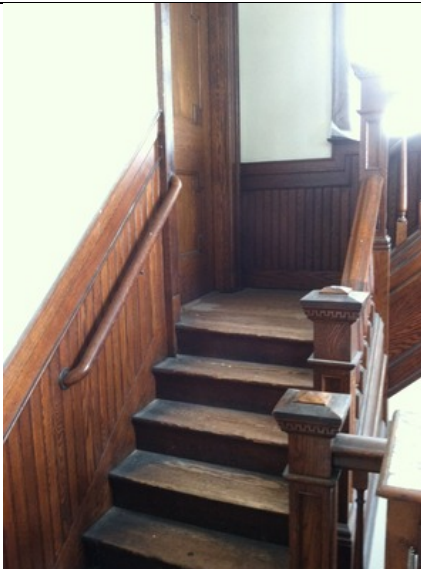
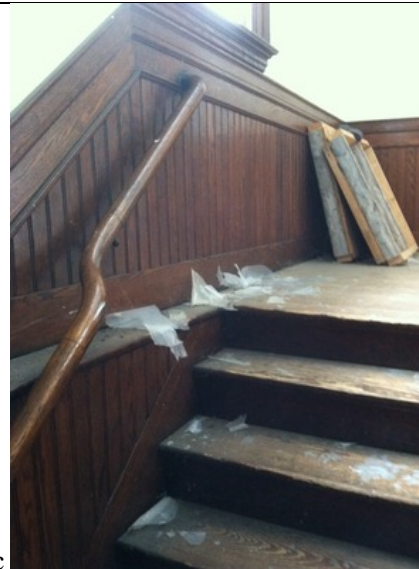
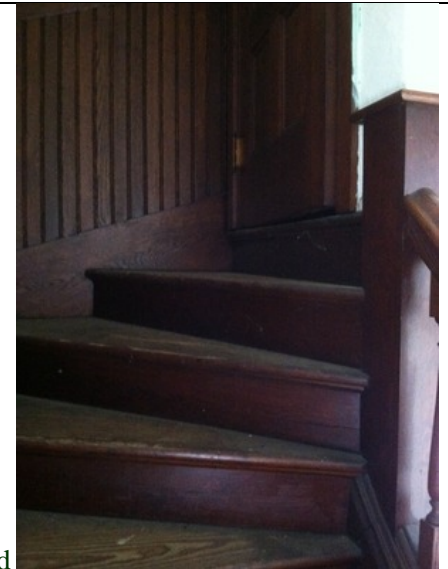
3.4.a

Egress stair to second floor is non-compliant due to:

- Non-compliant tread depth at 10"
- Non-compliant winders down from third floor
- Handrails lack extensions at top and bottom of run

- **521CMR 27.2 Treads and Risers:** On any given flight of stairs, all steps shall have uniform riser heights and uniform tread widths. See Fig. 27a.

- **521CMR 27.4 Stair Handrails:** Handrails shall comply with 27.4.1 Location, 27.4.2 Height, 27.4.3 Extensions, 27.4.4 Size, 27.4.5 Shape, 27.4.6 Surface, 27.4.7 Clearance, 27.4.8 End Condition, 27.4.9.

- *Request variance from MAAB to maintain existing handrails*
- *Install an additional compliant handrail on outside wall of the stairs if feasible and approved by MHC.*

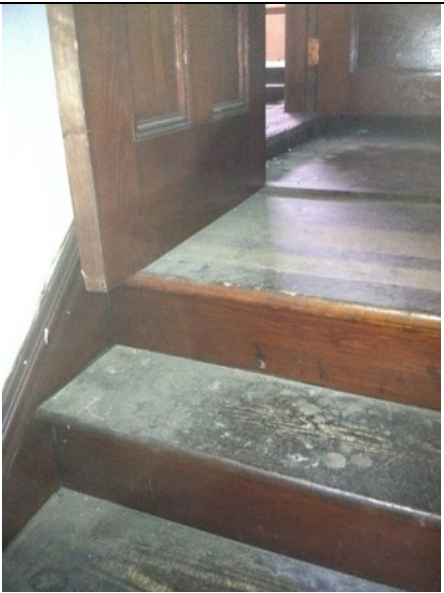
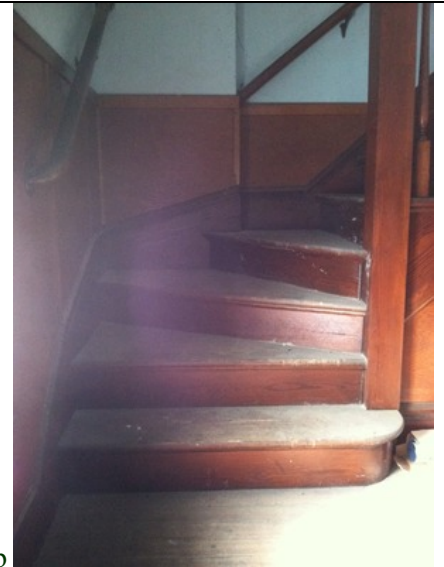
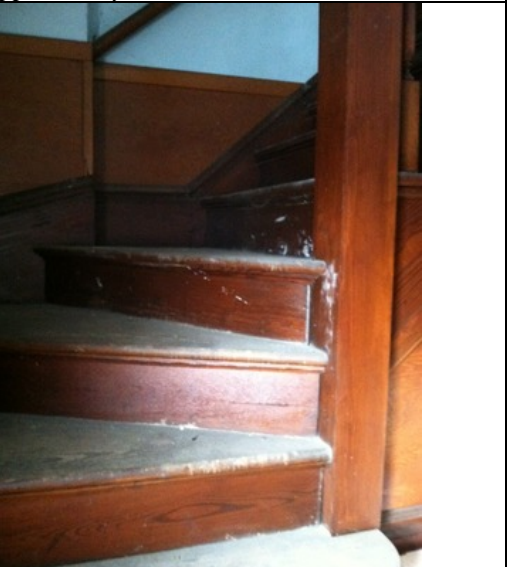
<p>3.5.a</p>

<p>Egress stairs from third floor are non-compliant due to:</p> <ul style="list-style-type: none"> • Door swing obstructs clear landing • Non-compliant tread depth at 10” and riser height at 7.5” • Non-compliant winders to mezzanine and third floor • Handrails are on one side only and are not continuous • Handrails lack extensions at top and bottom of run • <i>Request variance from MAAB to maintain existing handrails</i> • <i>Install an additional compliant handrail on outside wall of the stair if feasible and approved by MHC s.</i> 	<ul style="list-style-type: none"> • <u>521CMR 26.6 Maneuvering Clearance:</u> A minimum clear floor area shall be provided on both sides of all doors and gates. • <u>521CMR 27.2 Treads and Risers:</u> On any given flight of stairs, all steps shall have uniform riser heights and uniform tread widths. See Fig. 27a. • <u>521CMR 27.4 Stair Handrails:</u> Handrails shall comply with 27.4.1 Location, 27.4.2 Height, 27.4.3 Extensions, 27.4.4 Size, 27.4.5 Shape, 27.4.6 Surface, 27.4.7 Clearance, 27.4.8 End Condition, 27.4.9.

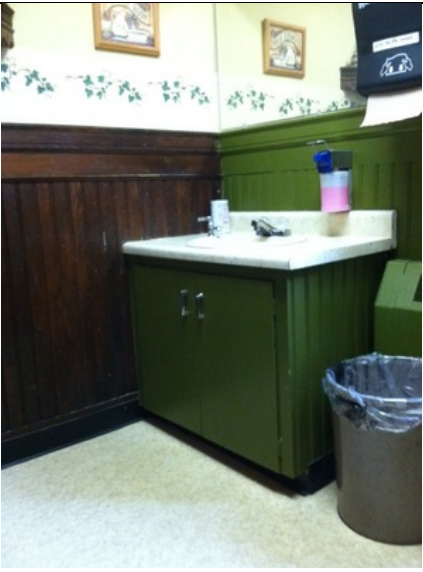
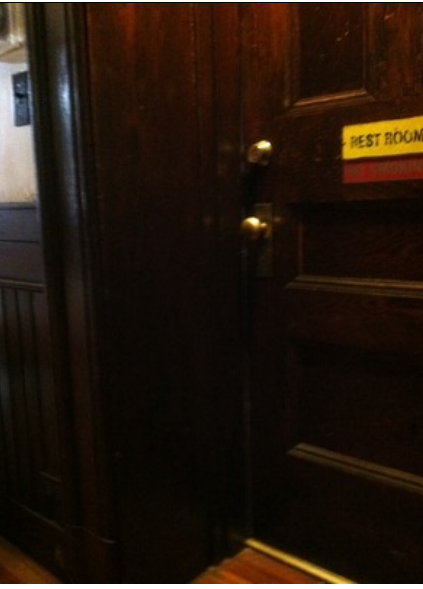
<p>First floor toilet room is non-compliant due to:</p> <ul style="list-style-type: none"> • Toilet rooms are not accessible. There are no accessible toilet rooms in the building. • Not accessible 29" clear on door • No push side clearance due to wall depth • Door handle is a round knob and non-compliant <ul style="list-style-type: none"> • <i>Renovate toilet rooms to make fully accessible.</i> • <i>Install new doors with compliant clear opening width and hardware.</i> <ul style="list-style-type: none"> • 521CMR 30.1-30.20 Public Toilet Rooms: In each adult public toilet room, at least one water closet and one sink in each location shall be accessible to persons in wheelchairs, or a separate accessible unisex toilet room shall be provided at each location. • 521CMR 26.5 Door Width: All doorways and openings that are required to be accessible shall have a clear opening of not less than 32 inches (32" = 813mm). • 521CMR 26.6.4 Door Push Side Clearance: Comply with Fig. 26e. 12" side clearance, 36" x 48" in front of door.

<ul style="list-style-type: none"> • 521CMR 26.11 Door Hardware: Type: Handles, pulls, latches, locks, and other operating devices on accessible doors shall have a shape that is easy to operate with one hand.

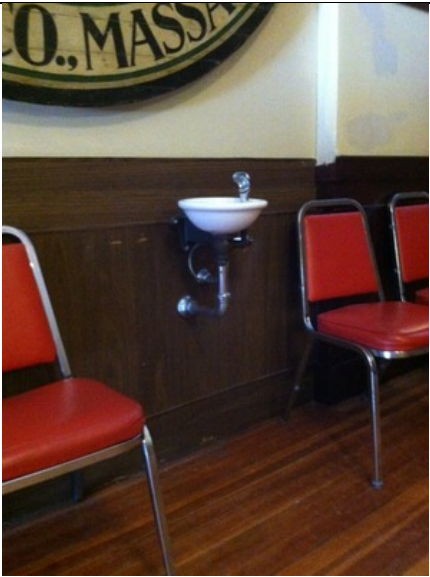
<p>5.1.a</p>	<p>Main hall water fountain is non-compliant due to:</p> <ul style="list-style-type: none"> • Non-compliant protrusion • <i>Remove water fountain</i> 	<ul style="list-style-type: none"> • <u>ADA 602.2 Drinking Fountains Clear Floor Space:</u> Units shall have a clear floor or ground space complying with 305 positioned for a forward approach and centered on the unit. Knee and toe clearance complying with 306 shall be provided. • <u>521CMR 36.1.1 General, Fig 36a:</u> Drinking fountains shall have a maximum height of 36 inches and a minimum knee clearance height of 27 inches. • <u>521CMR 36.2.1:</u> Cantilevered Units. • <u>521CMR 36.2.3:</u> Built-in Units. • <u>521CMR 20.6:</u> Protruding Objects
<p>5.2 Building Interior: General: <i>Doors and Doorways:</i></p>

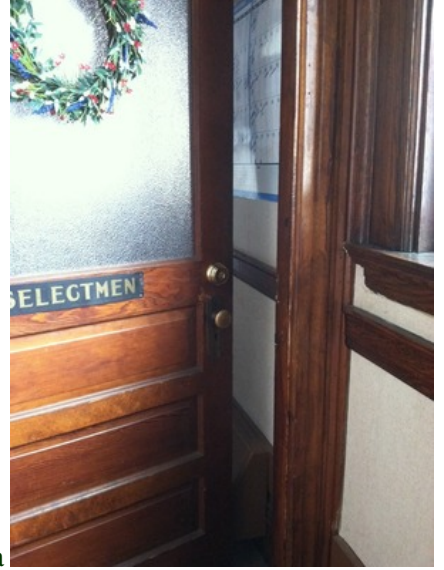
<p>First Floor Selectman's office is non-compliant due to:</p> <ul style="list-style-type: none"> • Insufficient push side clearance of 5". • Door hardware are non-compliant knobs. <p>• <i>Install new power door opener</i> • <i>Or request variance from MAAB.</i></p> <ul style="list-style-type: none"> • 521CMR 26.6.4 Door Push Side Clearance: Comply with Fig. 26e. 12" side clearance, 36" x 48" in front of door. • 521CMR 26.11 Door Hardware: Type: Handles, pulls, latches, locks, and other operating devices on accessible doors shall have a shape that is easy to operate with one hand.

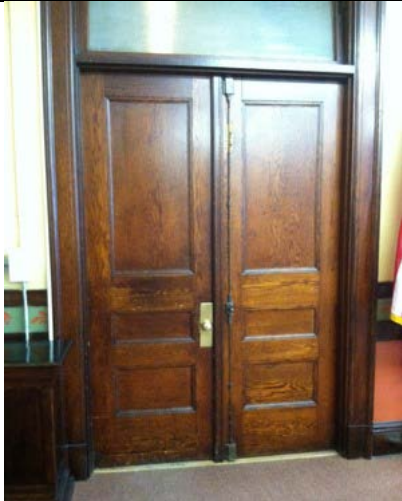
<p>5.8.a</p>	<p>Entrance to banquet hall is non-compliant due to:</p> <ul style="list-style-type: none"> • Entrance to the banquet hall has two independent door leaves, neither of which have a clear opening of the minimum 32 inches. • Door hardware are non-compliant knobs. <ul style="list-style-type: none"> • <i>Install new power door opener</i> • <i>Or request variance from MAAB.</i> 	<ul style="list-style-type: none"> • 521CMR 26.4 Double Leaf Doorways: A doorway having two independently operated door leaves shall have at least one leaf that meets the requirements of 521 CMR 26.5, Width and 521 CMR 26.6, Maneuvering Clearance. That leaf shall be an active leaf. • 521CMR 26.11 Door Hardware: Type: Handles, pulls, latches, locks, and other operating devices on accessible doors shall have a shape that is easy to operate with one hand.
--	---	--

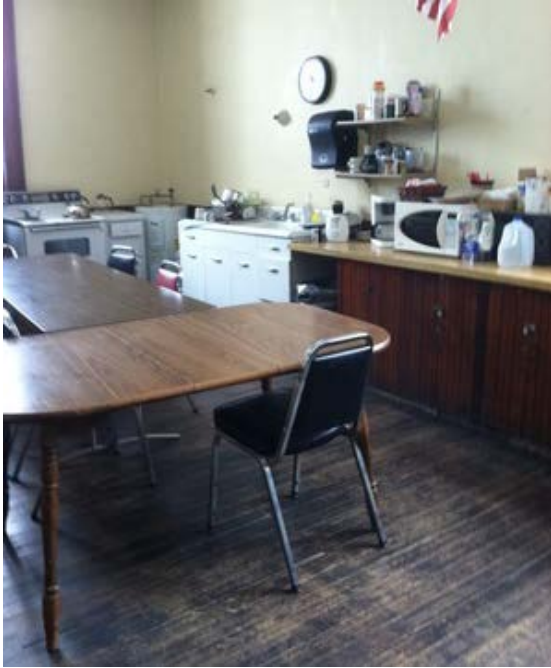
<p>5.9.a</p>	<p>First floor kitchen is non-compliant due to:</p> <ul style="list-style-type: none"> • Insufficient clear space • There is no kneespace under cooktops, sinks and cabinetry. 	<ul style="list-style-type: none"> • 521CMR 32.1 General: Non-commercial kitchens in public facilities such as classrooms and community rooms shall provide a clear space of 60 inches in diameter, measured 12 inches above the floor. • 521CMR 32.2 Countertops: Countertops that contain sinks and cooking units shall provide a minimum of 15 inches of clear countertop on at least one side of the cooking unit and on at least one side of the sink and shall have a clear space underneath that complies with 521CMR 32.6 Kneespace. Countertops shall be mounted no higher than 34 inches above the finished floor. See Fig. 32a. • 521CMR 32.5 Hardware: Cabinet hardware shall be operable with a closed fist. Cabinet opening devices shall be located at the top of base cabinets and at the bottom of wall cabinets.

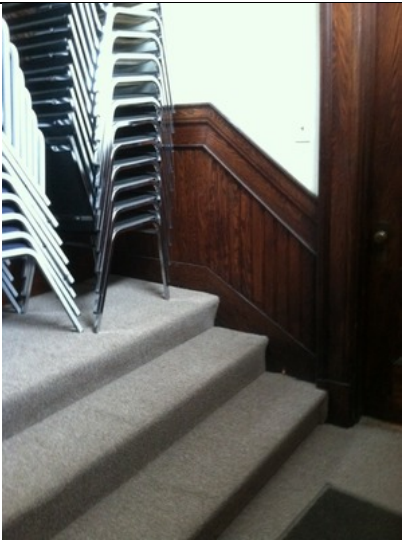
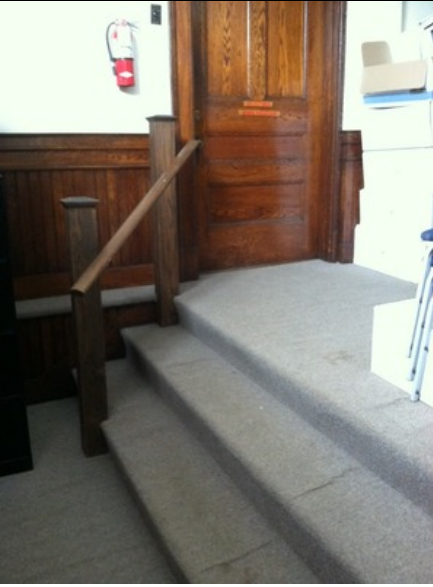
<p>5.10.a</p>	<p>Stairs to side exit are non-compliant due to:</p> <ul style="list-style-type: none"> • Handrails on one side only • Handrails lack extensions at top and bottom of run <ul style="list-style-type: none"> • Request variance from MAAB to maintain existing <i>handrails</i> • <i>Install an additional compliant handrail on outside wall of the stairs if feasible and approved by MHC.</i> 	<ul style="list-style-type: none"> • 521CMR 25.1 Entrances: All public entrance(s) of a building or tenancy in a building shall be accessible. • 521CMR 27.4 Stair Handrails: Handrails shall comply with 27.4.1 Location, 27.4.2 Height, 27.4.3 Extensions, 27.4.4 Size, 27.4.5 Shape, 27.4.6 Surface, 27.4.7 Clearance, 27.4.8 End Condition, 27.4.9

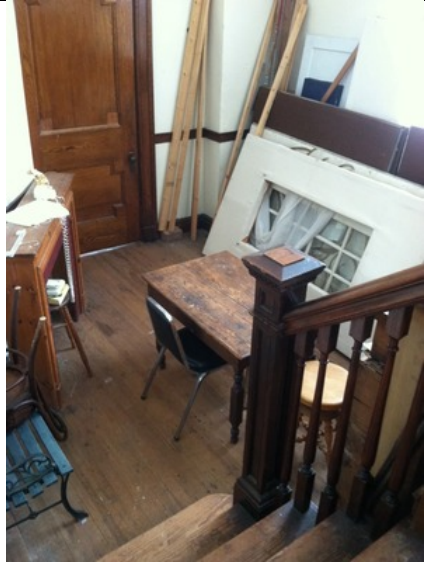
<p>5.11.a</p>	 	<p>Auditorium is non-compliant due to:</p> <ul style="list-style-type: none"> • Stairs to stage lack handrails • Inaccessible toilet room • Stage wings and dressing rooms are inaccessible • Handrails lack extensions at top and bottom of run <ul style="list-style-type: none"> • <i>Add lift to stage</i> • <i>Install compliant handrails on both sides of the stairs if feasible and approved by MHC.</i> 	<ul style="list-style-type: none"> • 521CMR 20.1 General: An accessible route shall provide a continuous unobstructed path connecting accessible spaces and elements inside and outside a facility. • 521CMR 30.1-30.20 Public Toilet Rooms: In each adult public toilet room, at least one water closet and one sink in each location shall be accessible to persons in wheelchairs, or a separate accessible unisex toilet room shall be provided at each location. • 521CMR 33.1 Dressing, Fitting and Changing Rooms: Where provided, dressing, fitting and changing rooms shall comply with 33.2 Distribution, 33.3 Location, 33.4 Size, 33.5 Doors, 33.6 Seat, 33.7 Mirror.

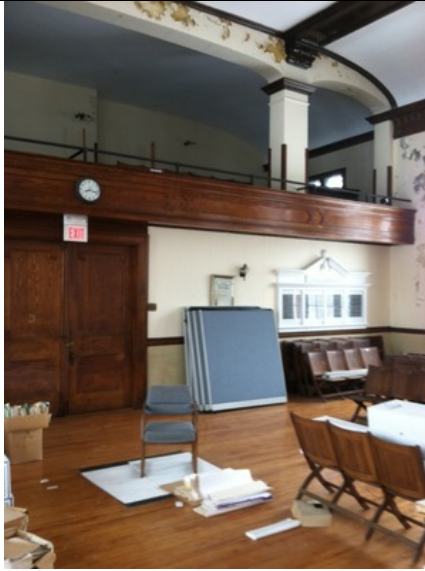
5.12.a

Balcony is non-compliant due to:

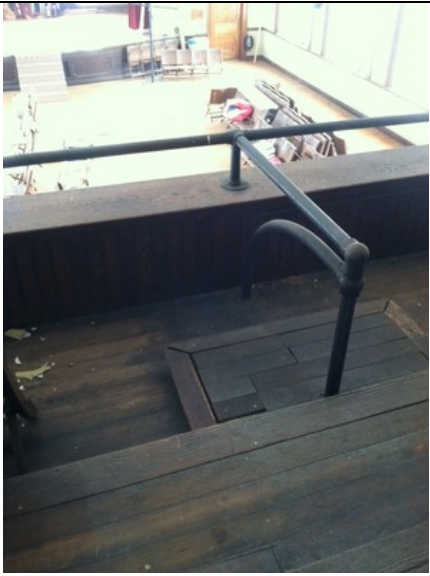
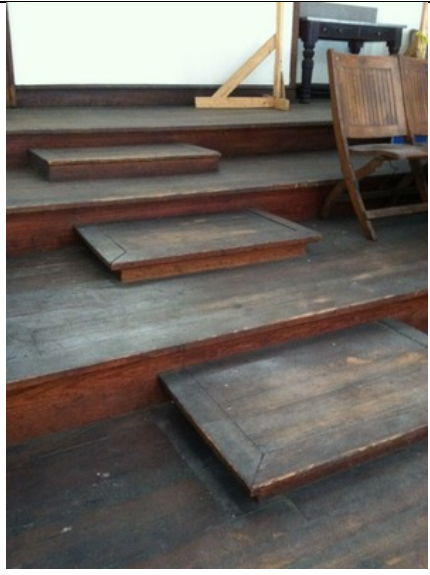
<p>Auditorium balcony is non-compliant due to:</p> <ul style="list-style-type: none"> • Balcony is inaccessible • Continuous railings are not provided at stairs • Guards are non-compliant at 27" • There is no accessible seating provided 	<ul style="list-style-type: none"> • <u>521CMR 20.1 General</u>: An accessible route shall provide a continuous unobstructed path connecting accessible spaces and elements inside and outside a facility. • <u>521CMR 27.4 Stair Handrails</u>: Handrails shall comply with 27.4.1 Location, 27.4.2 Height, 27.4.3 Extensions, 27.4.4 Size, 27.4.5 Shape, 27.4.6 Surface, 27.4.7 Clearance, 27.4.8 End Condition, 27.4.9.
<p>3.4.b</p>

<ul style="list-style-type: none"> • <i>Eliminate access to balcony</i>

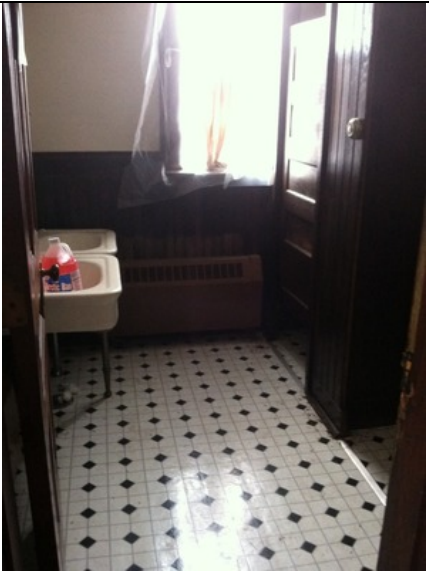
<p>5.14.a</p>

<p>Second floor toilet room is non-complaint due to:</p> <ul style="list-style-type: none"> • Threshold material transition exceeds 1/2" height • Insufficient push side clearance of 17" • Does not meet requirements for accessible toilet rooms <p>• <i>Renovate toilet rooms to make fully accessible.</i></p> <p>• <i>Install new doors with compliant clear opening width and hardware.</i></p>	<ul style="list-style-type: none"> • <u>521CMR 26.6.4 Door Push Side Clearance:</u> Comply with Fig. 26e. 12" side clearance, 36" x 48" in front of door. • <u>521CMR 26.10.1 Thresholds:</u> Thresholds shall not exceed 1/2" in height and shall be beveled on both sides with a slope no greater than one-in-two (1:2) (50%). • <u>521CMR 30.1-30.20 Public Toilet Rooms:</u> In each adult public toilet room, at least one water closet and one sink in each location shall be accessible to persons in wheelchairs, or a separate accessible unisex toilet room shall be provided at each location.

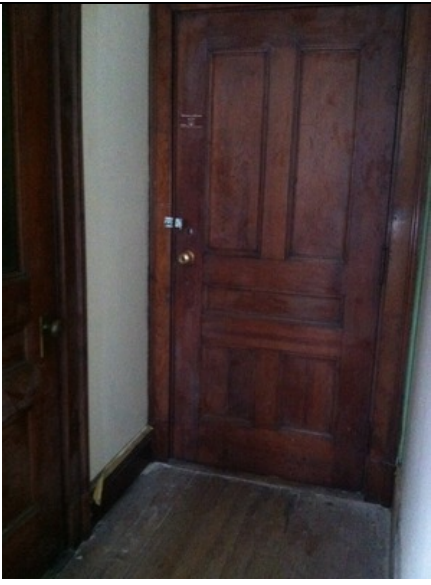
<p>5.15.a</p>

<p>Entrance to masonic hall is non-compliant due to:</p> <ul style="list-style-type: none"> • Insufficient push side clearance of 5" • Pocket door hardware • Floor level change to platform is greater than 1/2" and does not provide a ramp for access <p>• <i>Eliminate access to third floor.</i></p>	<ul style="list-style-type: none"> • <u>521CMR 26.6.4 Door Push Side Clearance:</u> Comply with Fig. 26e. 12" side clearance, 36" x 48" in front of door. • <u>521CMR 26.11 Door Hardware: Type:</u> Handles, pulls, latches, locks, and other operating devices on accessible doors shall have a shape that is easy to operate with one hand. • <u>521CMR 29.2.3 Level Changes:</u> Changes in level greater than 1/2 inch are not allowed unless a ramp, walkway, or means of vertical access complying with 521CMR is provided.
<p>5.15.b</p>

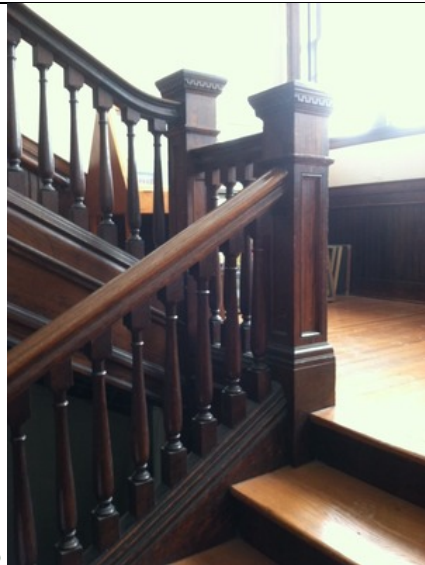
<p>1.2.a</p>	<p>Monumental stair is non-compliant due to guards and handrails:</p> <ul style="list-style-type: none"> • No rail on guard • Non-compliant railings, size of handrail • Gripping surface is interrupted and not continuous. • Handrails lack extensions at top and bottom of run. <p>• <i>Request variance from MAAB to maintain existing handrails</i></p> <p>• <i>Install an additional compliant handrail on outside wall of the stairs if feasible and approved by MHC.</i></p>	<ul style="list-style-type: none"> • IBC 1009.12 Handrails: Stairways shall have handrails on each side and shall comply with Section 1012. • IBC 1012.3.1 Handrail Type I: Handrails with a circular cross section shall have an outside diameter of at least 1 ¼ inches and not greater than 2 inches • IBC 1012.4 Handrail Continuity: Handrail gripping surfaces shall be continuous, without interruption by newel posts and other obstructions.
