Brookfield Town Hall Prioritized Recommendations Cost Estimate

**Prepared By
Austin Design, Inc.**

Town Hall - Phased access improvement and re-use study

6 Central Street - Brookfield, Massachusetts

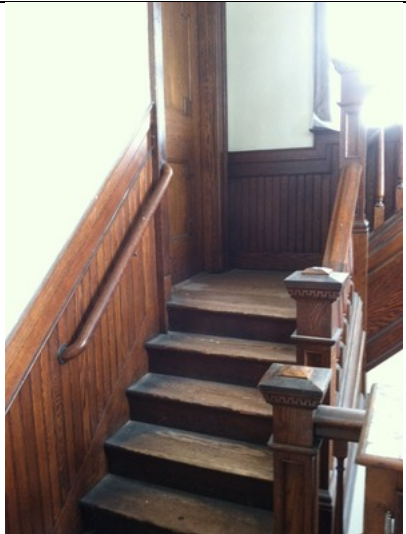
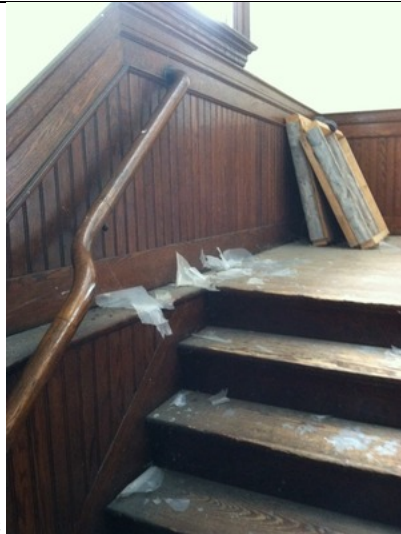
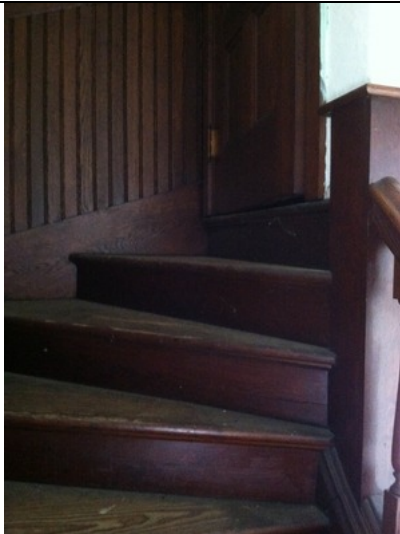
<p>1.4.a</p>	<p>Egress stair to second floor is non-compliant due to winders, tread depth and handrails:</p> <ul style="list-style-type: none"> • Non-compliant tread depth at 10" • Non-compliant winders down from third floor • Handrails lack extensions at top and bottom of run. <ul style="list-style-type: none"> • <i>Request variance from MAAB to maintain existing handrails</i> • <i>Install an additional compliant handrail on outside wall of the stairs if feasible and approved by MHC.</i> 	<ul style="list-style-type: none"> • IBC 1009.4.2 Riser Height and Tread Depth: Stair riser height shall be 7 inches maximum. Rectangular tread depths shall be 11 inches minimum. • IBC 1009.4.3 Winder Treads: Winder treads are not permitted in means of egress stairways except within a dwelling unit. • IBC 1012.6 Handrail Extensions: Handrails shall return to a wall, guard or the walking surface or shall be continuous to the handrail of an adjacent stair flight or ramp run.

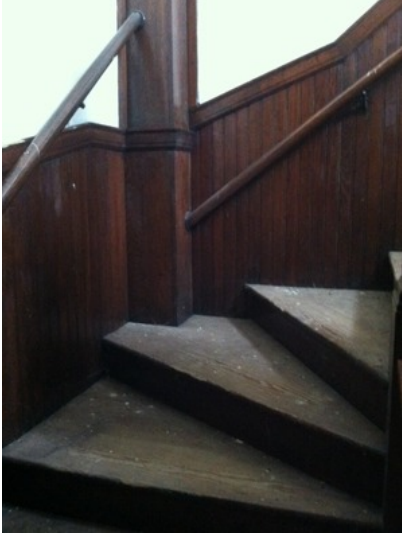
<p>2.1.a</p>	<p>Stair to mezzanine and third floor is non-compliant:</p> <ul style="list-style-type: none"> • Non-compliant tread depth at 10" and riser 7.5" • Non-compliant winders to mezzanine and third floor • Handrails are on one side only and are not continuous • Handrails are too large at 2 ¼" • Handrails lack extensions at top and bottom • Stairway is open to second floor landing and is not enclosed • <i>Request variance from MAAB to maintain existing handrails</i> • <i>Install an additional compliant handrail on outside wall of the stairs if feasible and approved by MHC</i> 	<ul style="list-style-type: none"> • IBC 1009.4.2 Riser Height and Tread Depth: Stair riser height shall be 7 inches maximum. Rectangular tread depths shall be 11 inches minimum. • IBC 1009.4.3 Winder Treads: Winder treads are not permitted in means of egress stairways except within a dwelling unit. • IBC 1009.12 Handrails: Stairways shall have handrails on each side and shall comply with Section 1012. • IBC 1012.3.1 Handrail Type I: Handrails with a circular cross section shall have an outside diameter of at least 1 ¼ inches and not greater than 2 inches

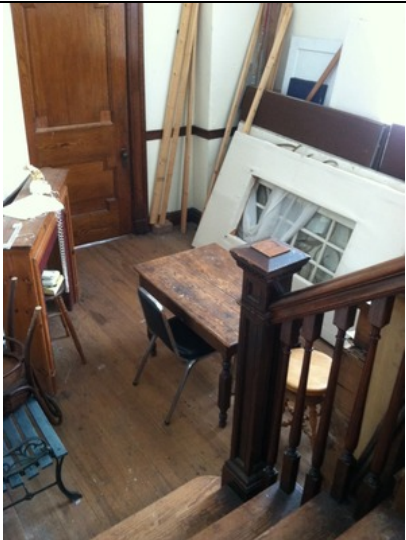
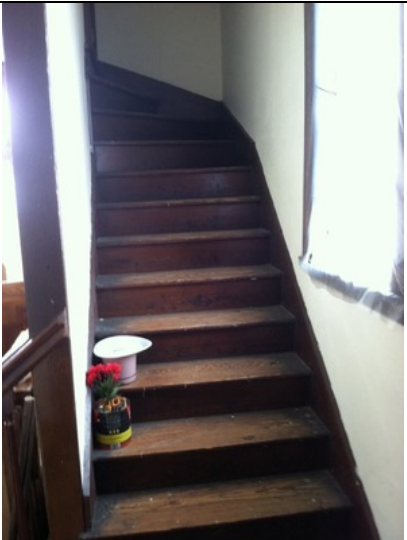
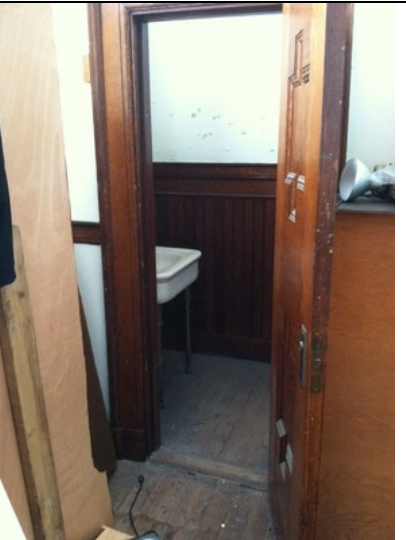
<p data-bbox="323 834 380 862">2.2.a</p>	<p data-bbox="968 319 1377 347">Auditorium is non-compliant due to:</p> <ul data-bbox="968 391 1528 591" style="list-style-type: none"> • Stairs to stage lack handrails. • Handrails lack extensions at top and bottom of run. • Doors lack panic hardware and closers. • Second egress is non-compliant in stair and door width <p data-bbox="968 802 1528 829">• <i>Install exit device and closer hardware on doors.</i></p>	<ul data-bbox="1554 326 2039 786" style="list-style-type: none"> • IBC 1009.12 Handrails: Stairways shall have handrails on each side and shall comply with Section 1012. • IBC 1012.6 Handrail Extensions: Handrails shall return to a wall, guard or the walking surface or shall be continuous to the handrail of an adjacent stair flight or ramp run. Where handrails are not continuous between flights, the handrails shall extend horizontally at least 12 inches beyond the top riser and continue to slope for the depth of one tread beyond the bottom riser.

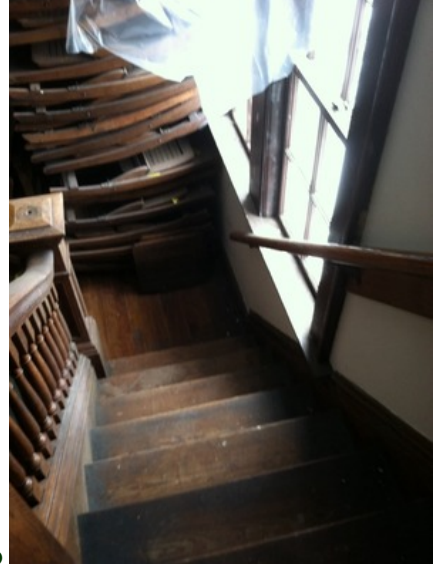
<p>2.3.a</p>	<p>Egress stair from balcony is non-compliant:</p> <ul style="list-style-type: none"> • Stair clear width reduced to 30" • Non-compliant tread depth at 10" and riser height at 7.5" • Handrails lack extensions at top and bottom of run. • Non-compliant window at stair <ul style="list-style-type: none"> • <i>Request variance from MAAB to maintain existing handrails</i> • <i>Install an additional compliant handrail on outside wall of the stairs if feasible and approved by MHC.</i> 	<ul style="list-style-type: none"> • IBC 1009.1 Stairway Width: The width of stairways shall be determined as specified in section 1005.1, but such width shall not be less than 44 inches. • IBC 1009.4.2 Riser Height and Tread Depth: Stair riser height shall be 7 inches maximum. Rectangular tread depths shall be 11 inches minimum. • IBC 1012.6 Handrail Extensions: Handrails shall return to a wall, guard or the walking surface or shall be continuous to the handrail of an adjacent stair flight or ramp run. Where handrails are not continuous between flights, the handrails shall extend horizontally at least 12 inches beyond the top riser and continue to slope for the depth of one tread beyond the bottom riser.

<p>2.3.b</p>		<ul style="list-style-type: none"> • IBC 2406.4 Hazardous Locations: The following shall be considered hazardous locations requiring safety glazing materials: 10. Glazing adjacent to stairways, landings and ramps within 36 inches horizontally of a walking surface.

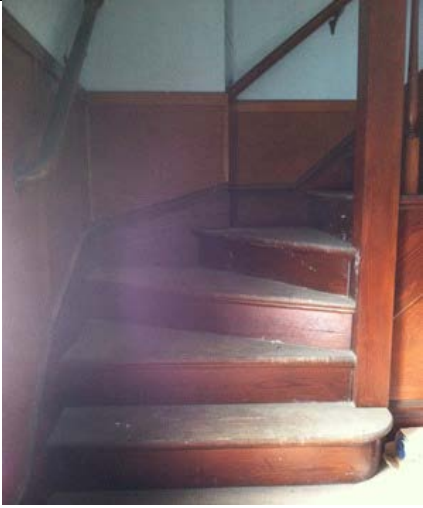
<p>3.1.a</p>	<p>Egress stairs from third floor are non-compliant:</p> <ul style="list-style-type: none"> • Non-compliant tread depth at 10” and riser height at 7.5” • Non-compliant winders to mezzanine and third floor • Door swing obstructs clear landing • Handrails are on one side only and are not continuous • Handrails lack extensions at top and bottom of run <ul style="list-style-type: none"> • <i>Request variance from MAAB to maintain existing handrails</i> • <i>Install an additional compliant handrail on outside wall of the stairs if feasible and approved by MHC.</i> 	<ul style="list-style-type: none"> • IBC 1009.4.2 Riser Height and Tread Depth: Stair riser height shall be 7 inches maximum. The riser height shall be measured vertically between the leading edges of adjacent of treads. Rectangular tread depths shall be 11 inches minimum measured horizontally between the vertical planes of the foremost projection of adjacent treads and at a right angle to the tread’s leading edge. • IBC 1009.4.3 Winder Treads: Winder treads are not permitted in means of egress stairways except within a dwelling unit. • IBC 1009.5 Stairway Landings: There shall be floor or landing at the top and bottom of each stairway. The width of the landings shall not be less than the width of stairways they serve.

<p>3.1.b</p>		<ul style="list-style-type: none"> • IBC 1009.12 Handrails: Stairways shall have handrails on each side and shall comply with Section 1012. • IBC 1012.6 Handrail Extensions: Handrails shall return to a wall, guard or the walking surface or shall be continuous to the handrail of an adjacent stair flight or ramp run.
